I-79 Crash – Jan. 31st

Cranberry Township Fires – Jan. 28th

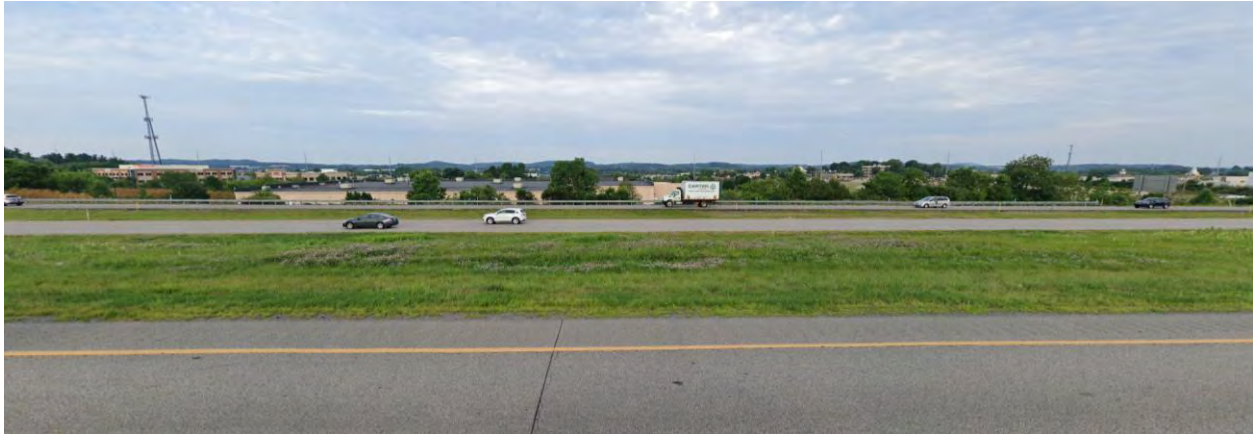
The sedan came to a stop in the median facing north, closer to the southbound lanes. The median slants down from the north lanes to the south as seen in the pictures below.

Figure 1 – View of MM-78.6 from Northbound Lanes

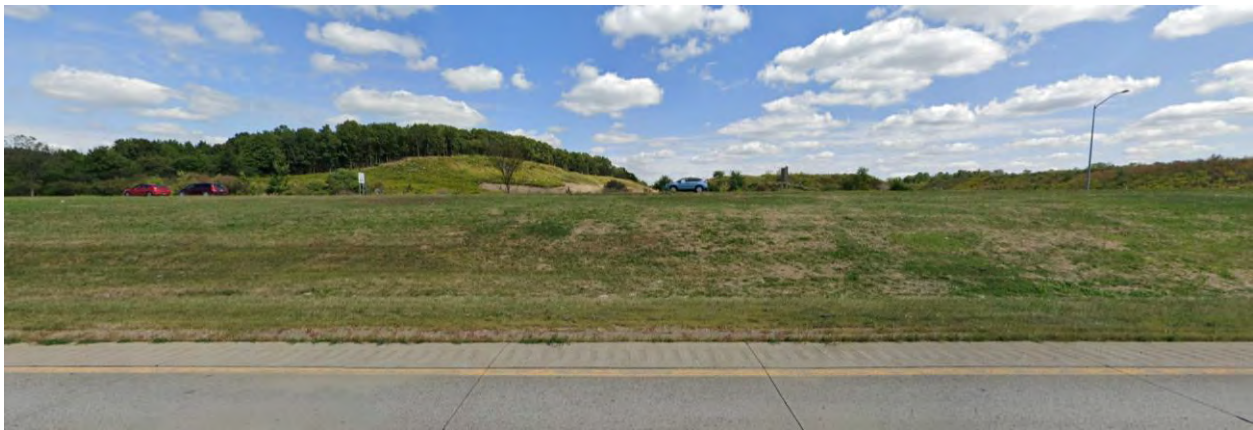
Figure 2 - View of MM-78.6 from Southbound Lanes

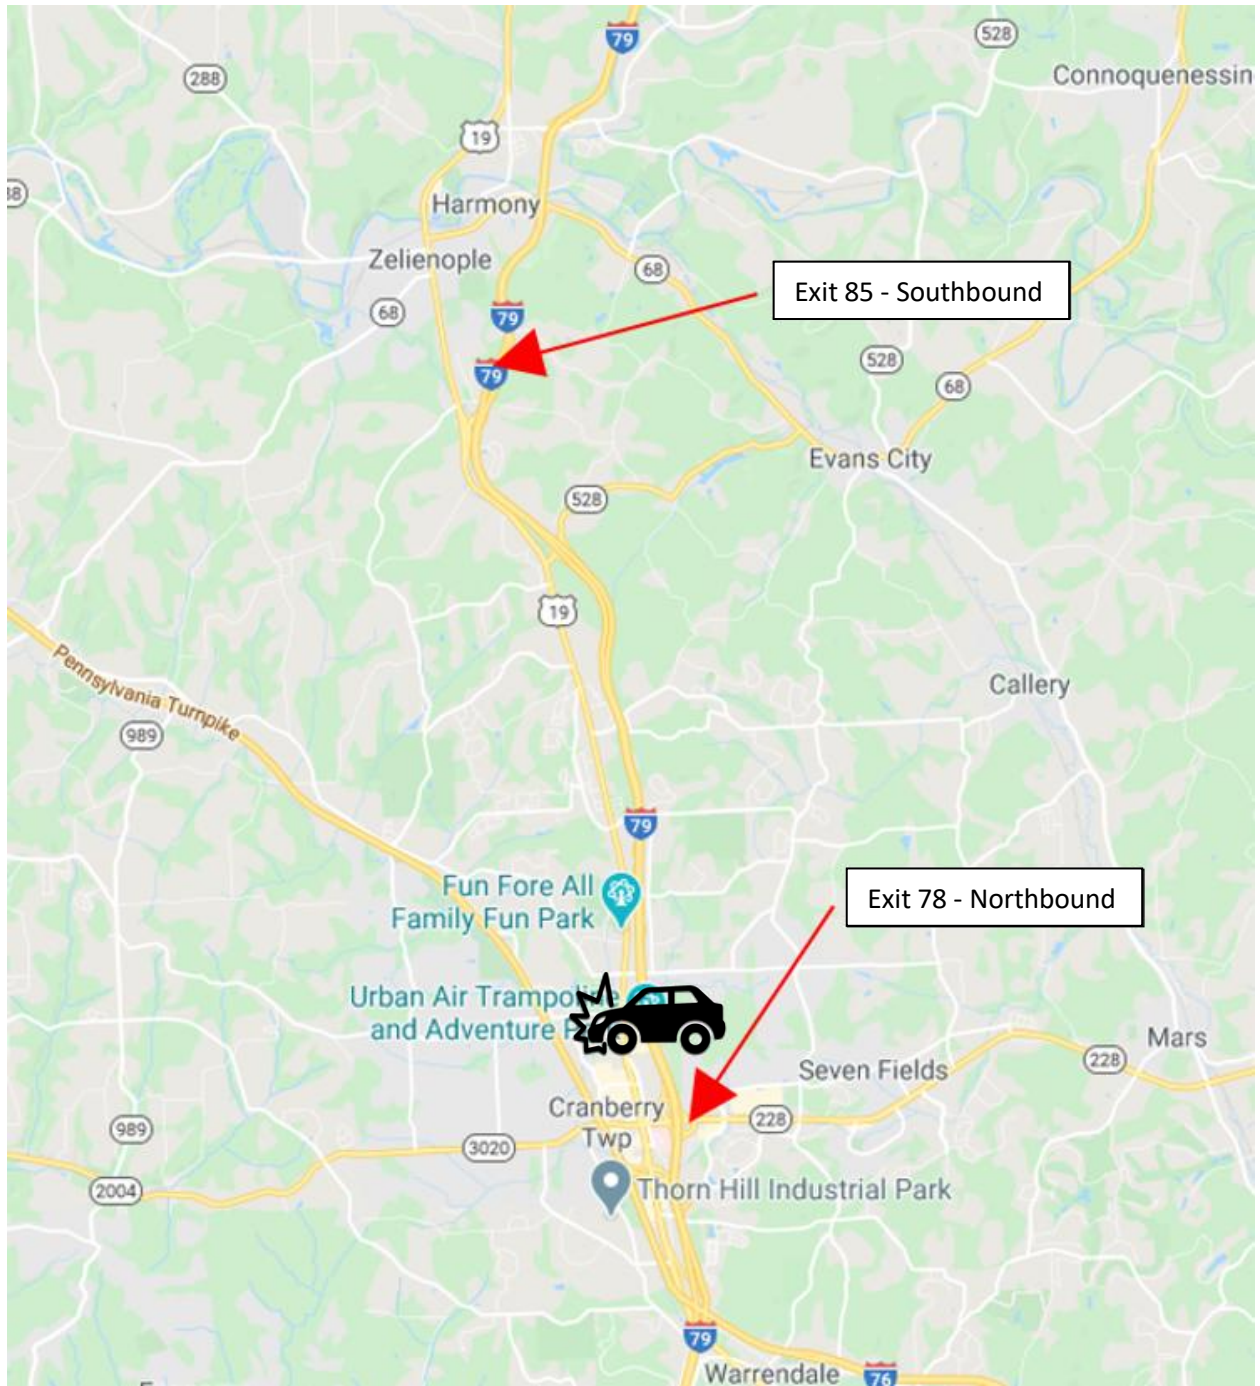
The sedan sustained extensive damage and debris was scattered on both sides of the Interstate. First responders originally closed the left lanes on both sides of the Interstate. Southbound lanes were closed at Exit 85 Evans City in Jackson Township around 1630, and shortly after the Northbound traffic was halted at exit 78 to Route 228. Figure 3 on the next page shows the traffic blockage.

Figure 3 - Traffic Blockage

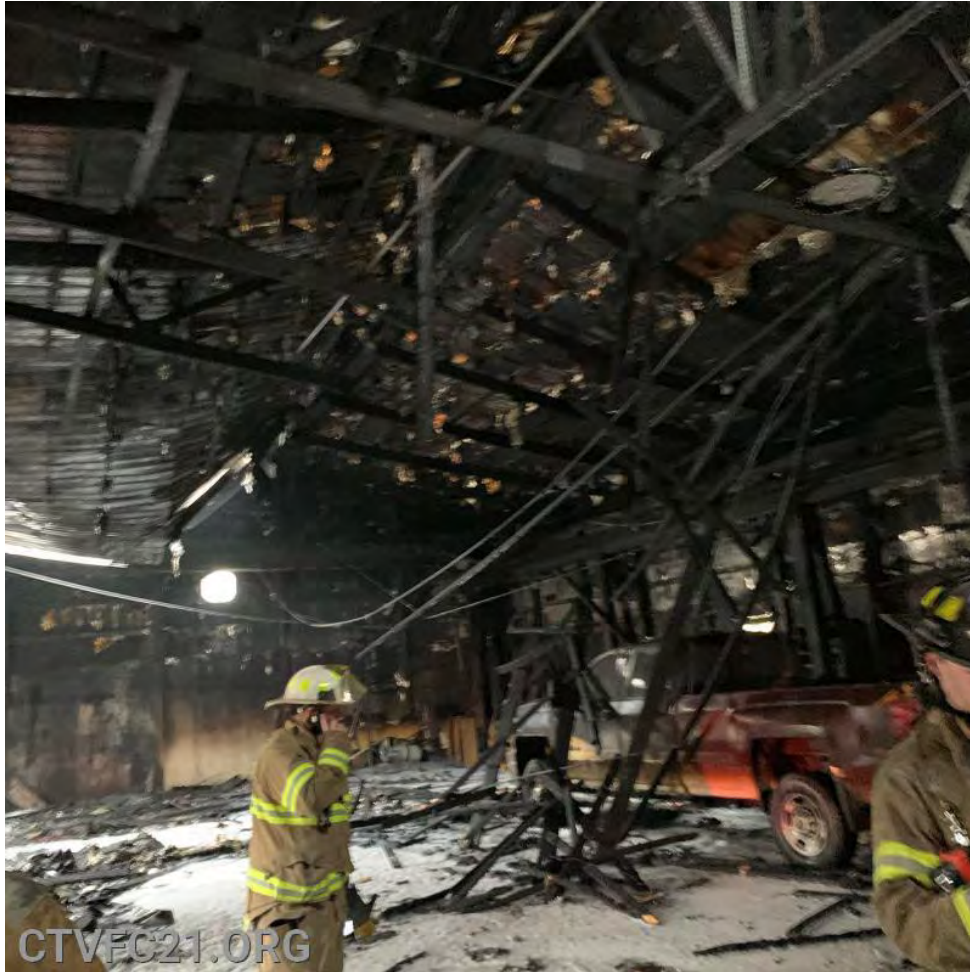
The crews encountered heavy smoke and fire from a large commercial garage, which upon further investigation contained unknown chemicals and vehicles. The Fire was reported under control at 1210, and the units cleared at approximately 1400.

Figure 4 - Commercial Structure Fire

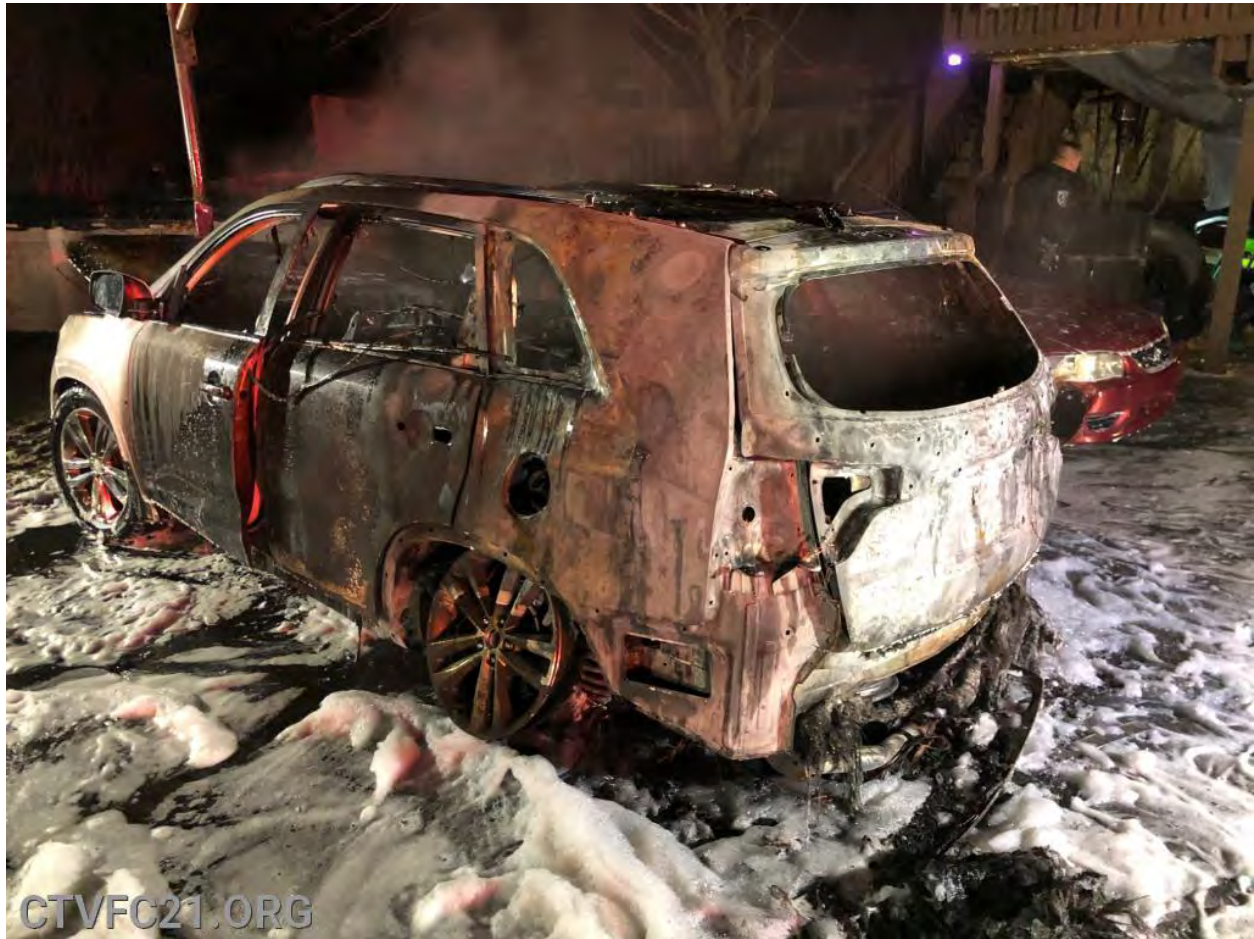
Station 90 was dispatched a second time on January 28th at 2358, this time for a structure fire in Cranberry Township. A vehicle was seen on fire in a driveway, endangering a nearby house. Soon after arriving to the scene, firefighters extinguished the car with no impact to the structure.

Figure 5 - Vehicle Fire
