State Route 18 Corridor Operations Planning Study From State Route 551 to State Route 351

Beaver Falls, Koppel, and Big Beaver Boroughs Beaver County, Pennsylvania December 2022

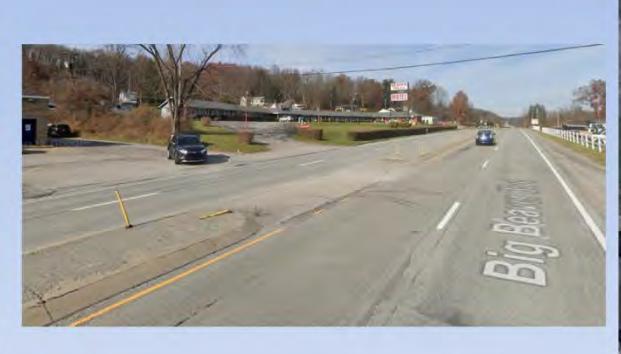
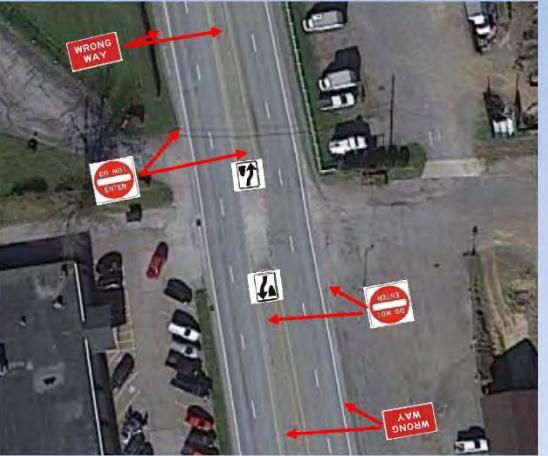
OBSERVATION: There are 9 median openings along the corridor that do not have the proper signage (Wrong Way, Do Not Enter, Around Median): Near the Dollar General, South and North Entrance to Big Beaver Plaza, at Giuseppes, Self Storage/Adult Store, Buttermilk Falls Natural Area, Bowling Alley/ Bills Valhalla, Norwood Drive, and Ida Street.

- Add DO NOT ENTER signs to all locations listed above and should be placed directly in view of a roadway user.
- Add supplemental WRONG WAY signs to helps emphasize the DO NOT ENTER.
- Add Keep Right signs at the median to alert drivers on where to go.

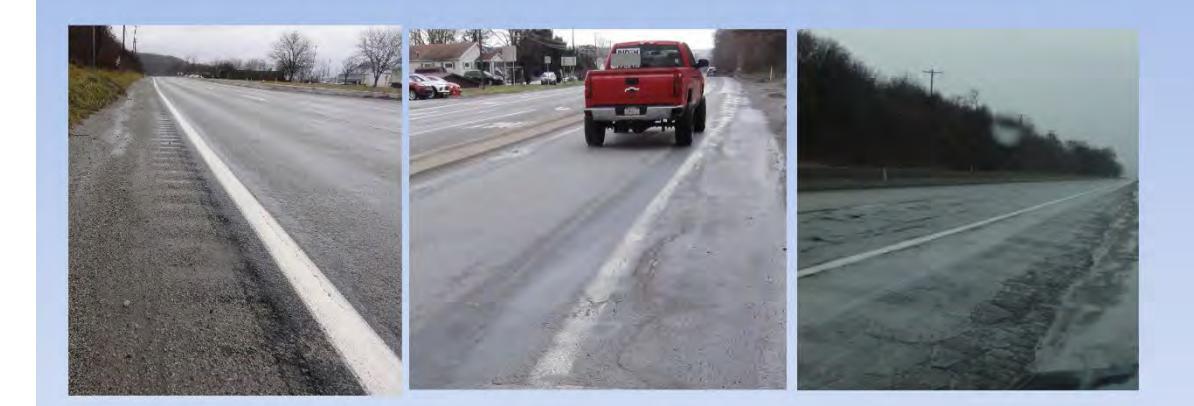
OBSERVATION:Edge line rumble strips are in place through part of the corridor. Their usage is not complete. Pavement rutting and washboarding was noted in locations within the corridor.

- Provide edge line rumble strips continuously through the corridor to help drivers who drift out of
- the travel lane. Business accesses should be excepted. Upgrade shoulders where needed.
- Repave the corridor to ensure a smooth riding surface when required.

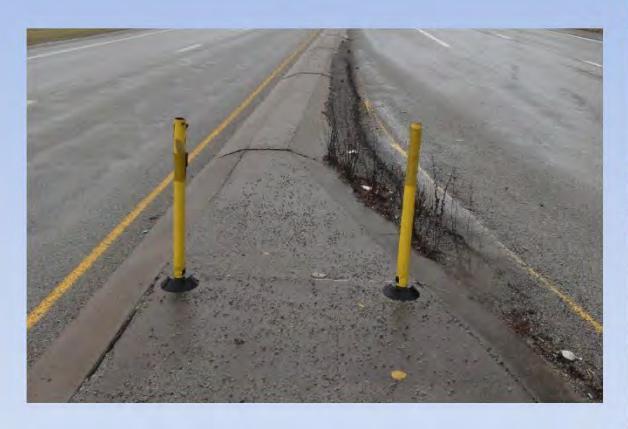
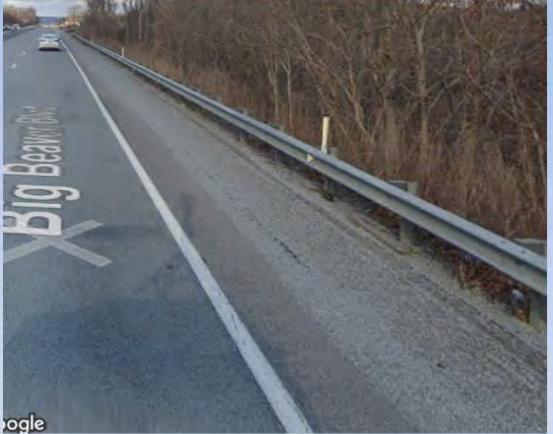
OBSERVATION: Delineators are in place within the corridor, but most are in poor shape and lack the actual delineation. They are especially ineffective at night.

- Upgrade delineation where needed to maximize the visibility of shoulders and medians.
- Median delineators should be retroreflective on both sides.
- Ensure that raised pavement markers are visible.

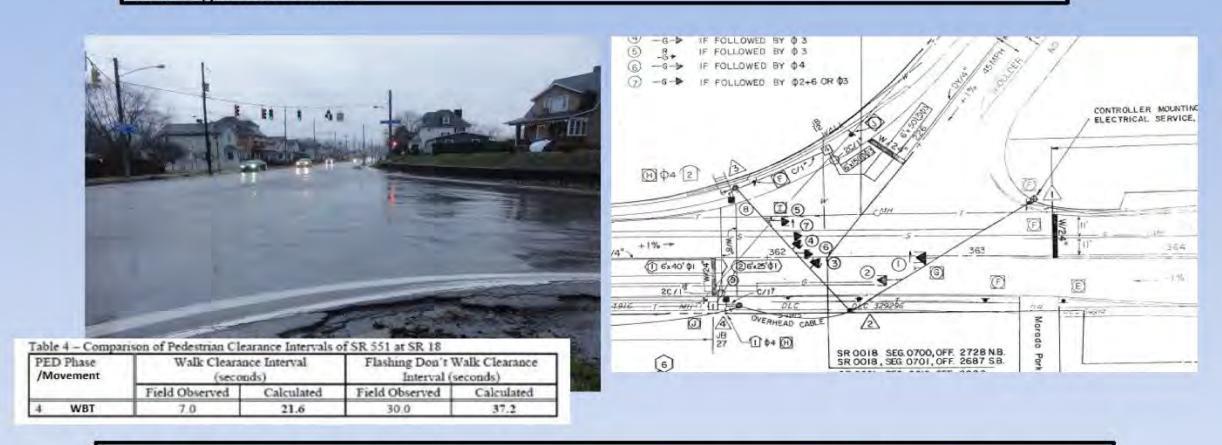
OBSERVATION: The pedestrian crossing on the west leg appears to use pedestrian timings too short for the crossing. A flashing DON'T WALK time of 30 seconds was timed. Also, the crossing is not shown on the signal permit for this intersection. Stop bars and crosswalk markings aren't visible.

- Provide proper pedestrian timings for this intersection. Ensure that the signal permit is updated for the current operation with proper reviews.
- The crosswalk as shown requires 37 seconds of flashing DON'T WALK timing.
- Upgrade to countdown signal heads due to the length of the crossing.
- Upgrade to provide properly visible stop bars and crosswalk markings.
- Consider adding an all-pedestrian phase for crossings due to the length of crossing.

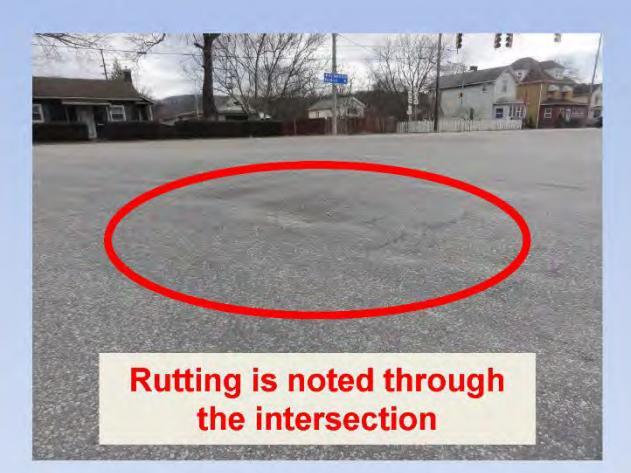
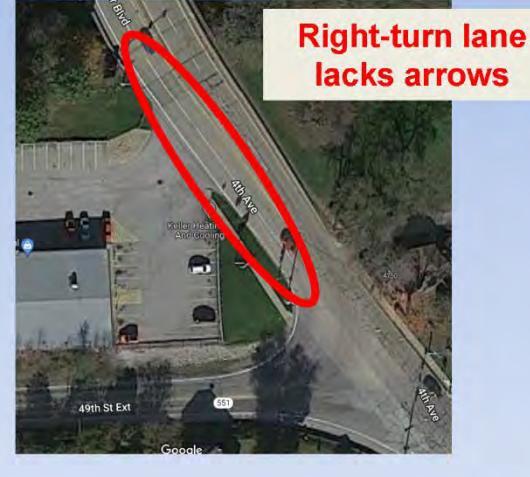
OBSERVATION: The southbound right-turn movement is wide for trucks, resulting in relatively high turning speeds. Pavement is rutted through the intersection. The southbound right-turn lane lacks pavement marking arrows.

- Investigate tightening the corner radius for the northwest quadrant to slow turning vehicles, and reduce pedestrian crossing distances.
- · Upgrade the pavement through the intersection to eliminate ruts
- Add pavement marking arrows through the intersection.

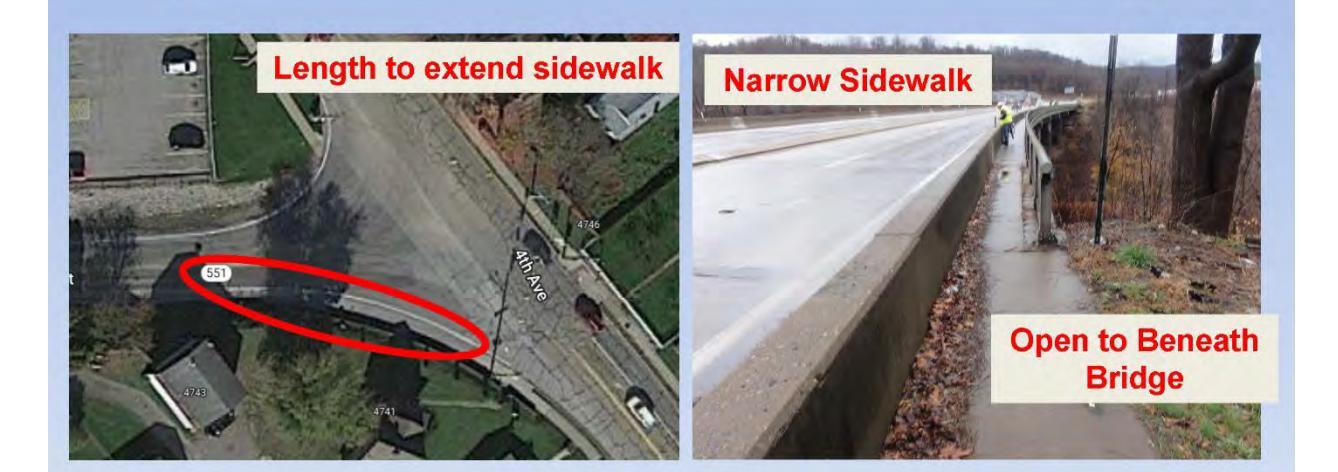
OBSERVATION: The sidewalk in the southwest quadrant transitions to shoulder within the walking paths through the intersection. The bridge to the north has a narrow sidewalk, narrower than the minimum for ADA. There are paths suggesting that pedestrians walk beneath the bridge.

- Extend the sidewalk farther west past the intersection
- Add a fence to discourage pedestrians from walking beneath the bridge
- When the bridge is rehabilitated or replaced, provide proper width for ADA, at least 5 feet.

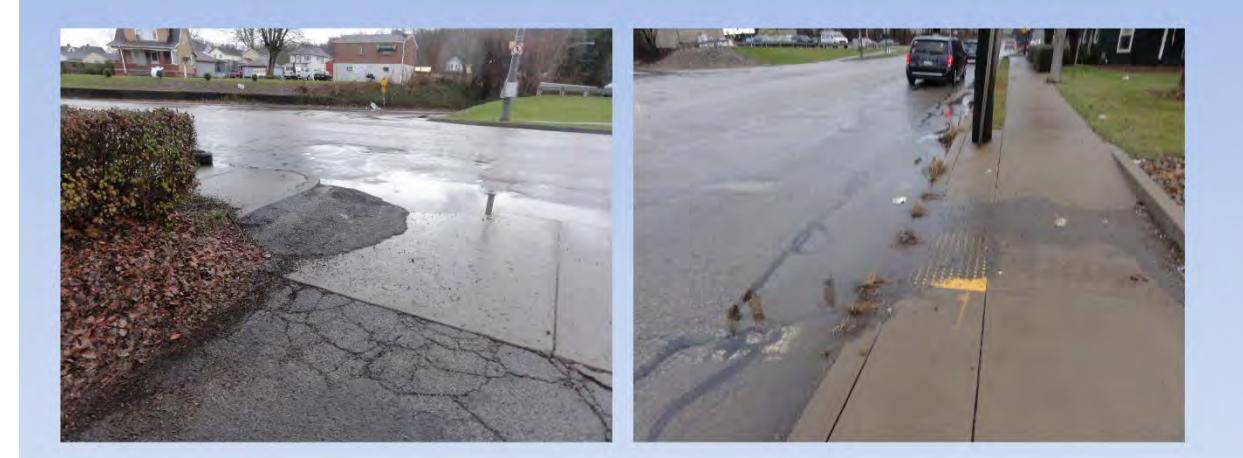
OBSERVATION: There is a clogged inlet in the southeast quadrant; ponding was observed in the through lane. Utility poles are very close to the through lane.

- Clean inlets regularly to ensure that they drain water properly.
- Repave and eliminate low spots that do not drain properly.
- Add utility pole collars to poles to maximize retroreflectivity.

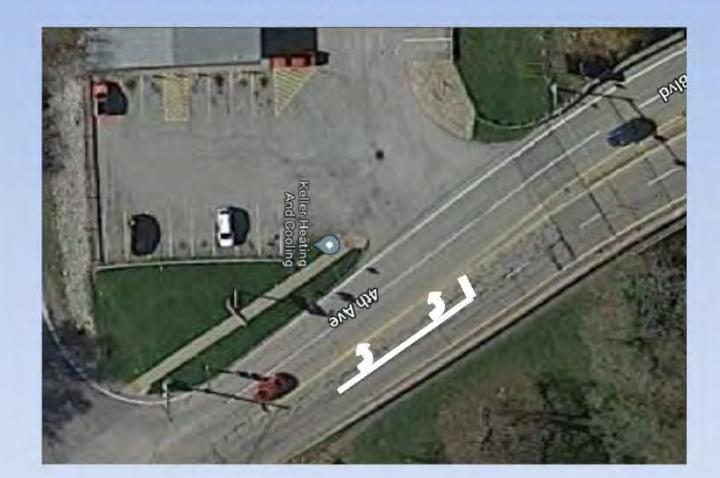
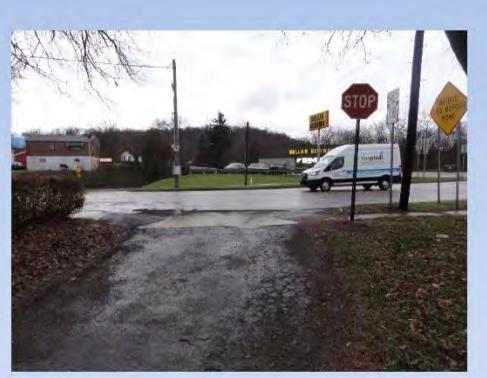
OBSERVATION:Northbound trucks were passed through the intersection before the second through lane opened; northbound traffic turning left into the Dollar General waits in the through lane; and the alley east of the intersection is located within the intersection. The All-Red time for State Route 18 is low.

- Fit a northbound left-turn lane for the Dollar General. This would also discourage traffic to pass before the second through lane starts.
- Ideally, the alley should have a signalized phase. Absent of that, reconfigure it to be right in-right out.
- Utilize the calculated 3.0 seconds of All-Red time versus the 2.2 seconds currently in use.

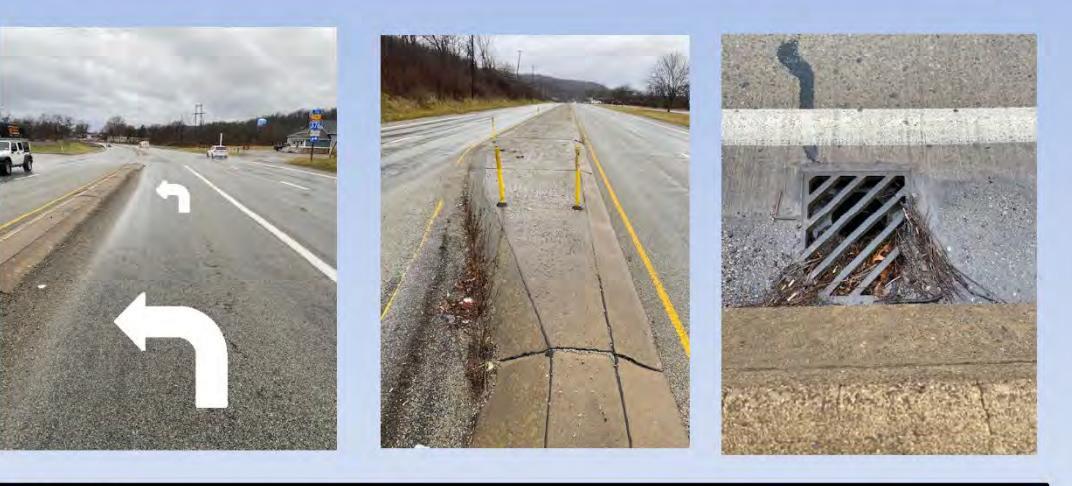
OBSERVATION: The southern entrance to the plaza has a pocket left turn lane but none at the northern entrance. The median between the northern entrance and southern entrance is showing signs of severe deterioration and the delineation no longer is effective. There are several drainage inlets between the southern entrance and the bridge that are clogged.

- Add left turn lane pavement markings to pocket left turn lane.
- Remove debris, weeds, and loose concrete from median. Long-term: replace mountable median with median barrier.
- Replace broken or worn out delineation.
- Remove debris from inlets.

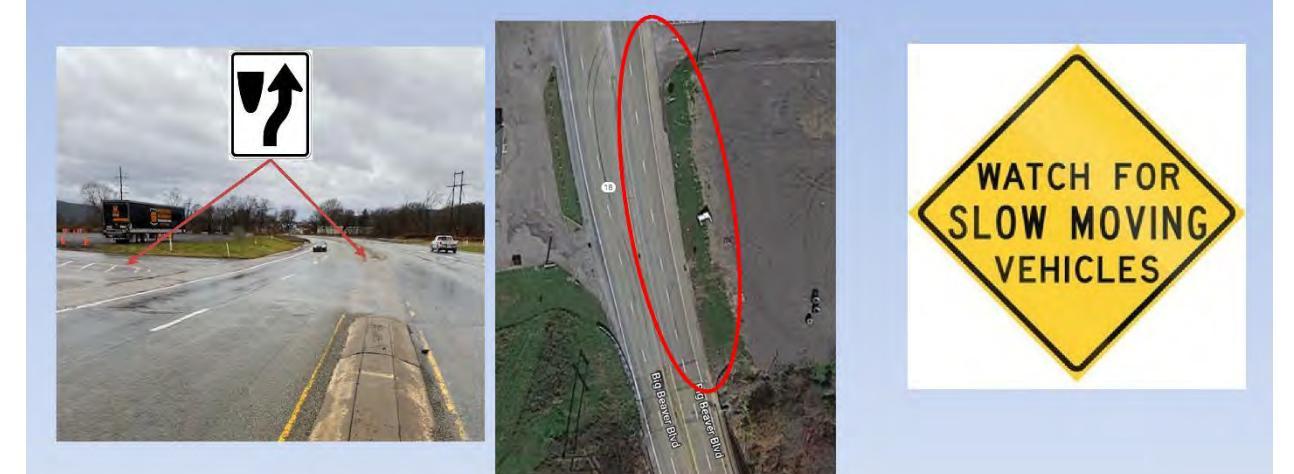
OBSERVATION: The southern entrance to the plaza lacks proper signage and has a solid white line across the entrance. There is a lack of sidewalk connectivity from the bridge to the Big Beaver Plaza. There is the potential to encounter slowing traffic with trailer for the ATV business as well as the commercial driving school.

- Add two "KEEP RIGHT" signs to intersection.
- Replace solid white line with dotted line, indicating the entrance and exit to the plaza.
- Add a sidewalk connection from the bridge to the Big Beaver Plaza.
- Add "WATCH FOR SLOW MOVING VEHICLES" signs near the plaza.

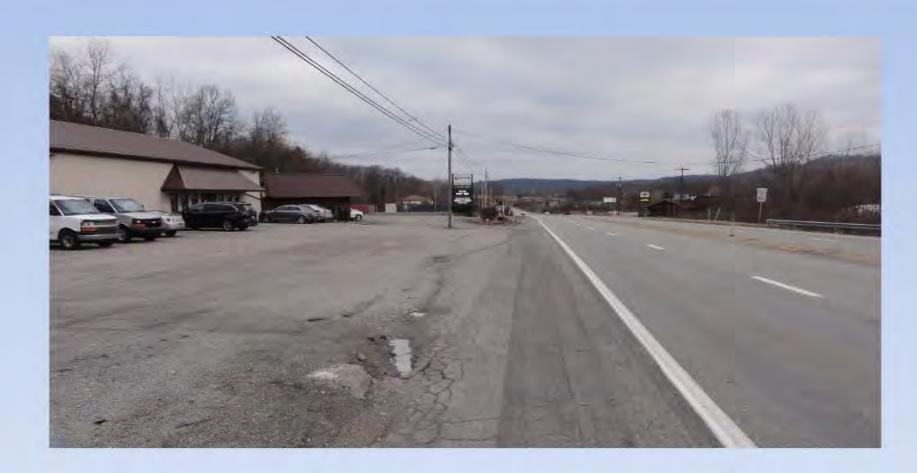
OBSERVATION: The cross section of the corridor is comprised of four through lanes with turn lane use inconsistent. Median openings are present at certain locations. Mid to major driveways often lack turn lanes, resulting in traffic waiting to turn left from the left lane, mixing stopped vehicles with high speed vehicles passing. The median openings add to this conflict by encouraging traffic to turn at these locations.

- Consider one of three options:
- Option 1: Reduce to one-lane per direction and add two-way left-turn lane
- Option 2: Keep 2 lanes per direction and add two-way left-turn lane
- Option 3: Add barrier to prohibit left-turns, and establish jughandles at certain frequencies

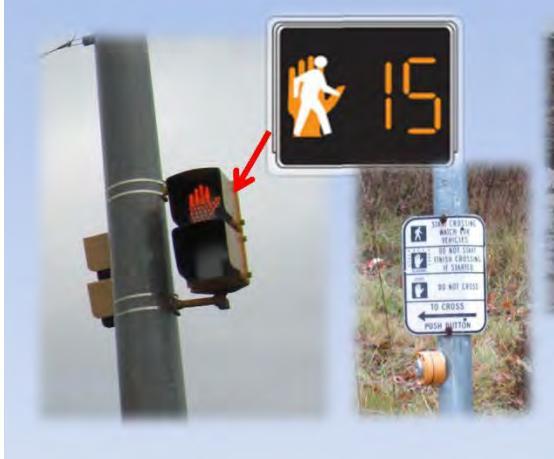
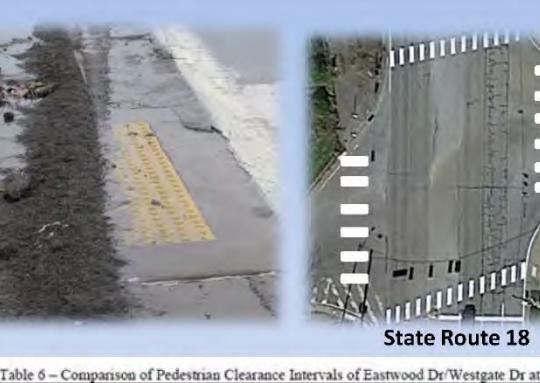
OBSERVATION: None of the pedestrian push buttons work. Pedestrian signal heads are outdated and do not have the countdown display. Crosswalk pavement markings are faded across State Route 18 and missing across Eastwood Drive and Westgate Drive. ADA Ramps are covered with asphalt and debris.

- · Install new pedestrian push buttons.
- · Install new countdown pedestrian signal heads.
- Install new high visibility crosswalks on all approaches.
- Clear, repair, or replace ADA ramps.

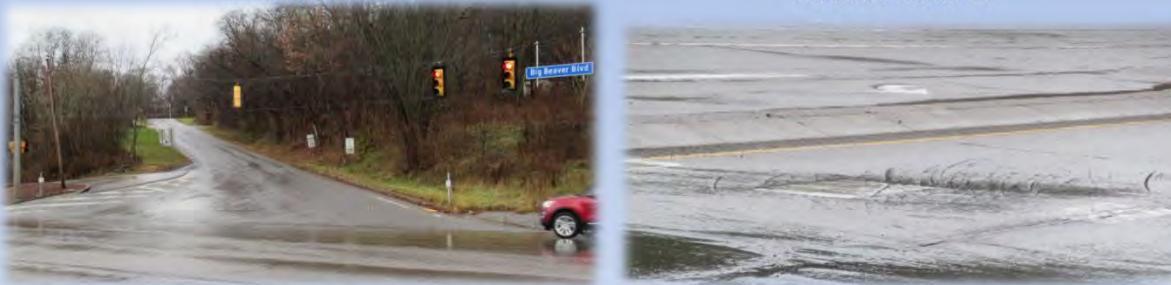
OBSERVATION: The slope and skew of the EB Eastwood Drive approach causes difficult turning movements for vehicles turning onto State Route 18. There are scrapes in the pavement from vehicles bottoming-out making the EB right turn.

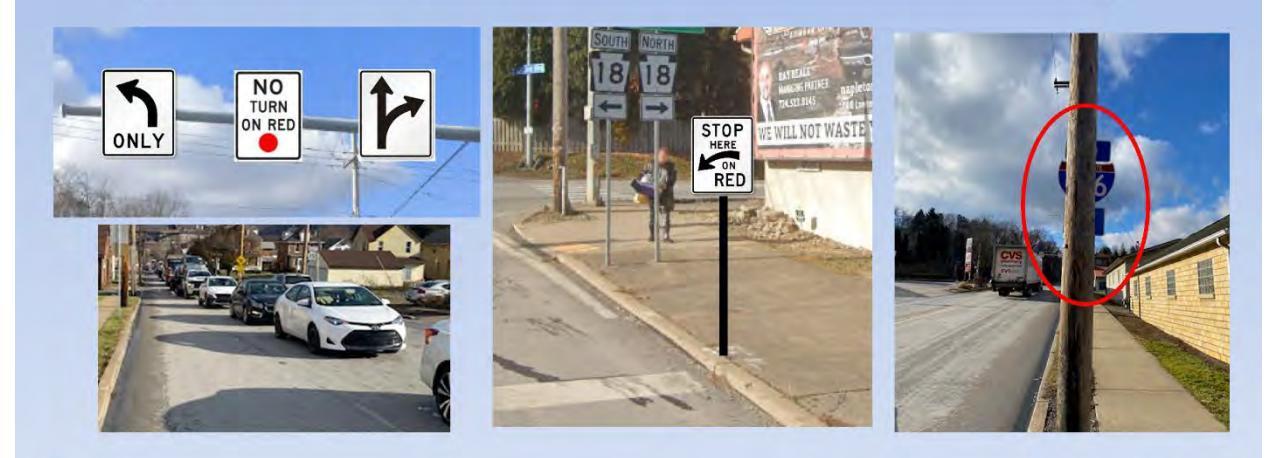
OBSERVATIONS: The current lane configuration for westbound traffic is causing excessive delays and aggressive driving. There are missing supplemental STOP HERE ON RED signs which is important due to the amount of large truck that traverse the intersection. Due to the geometry, vegetation, and lack of set backs, right turning vehicles have limited sight. The I-376 sign is posted right behind a utility pole.

- Switch the current lane configuration for WB traffic to a dedicated Left and Through/Right.
- · Add supplemental STOP HERE ON RED signs to all four approaches.
- Add NO RIGHT TURN ON RED signs to all approaches due to poor sight distances.
- Relocate/reposition Interstate sign so that it visible, seek permission from utility company to mount on pole.

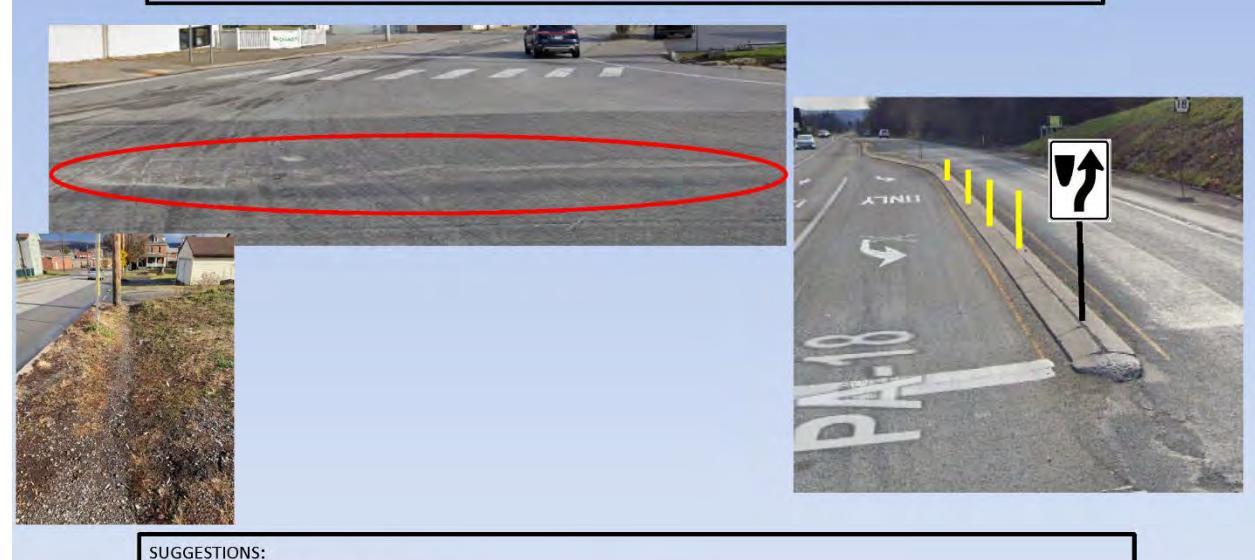
Figure 41: State Route 351 and State Route 18 - Pavement and Pedestrian Network

OBSERVATIONS: There is evidence of rutting in the middle of the intersection causing motorists to take a non-conventional travel through the intersection. Several pedestrians were observed at the intersection, however there are missing gaps in the sidewalk connections. The northbound median on Route 18 lacks delineations and proper signage.

- Repave the intersection.
- Add delineators and KEEP RIGHT sign to the median.
- Add missing sidewalk connections (see next slide).

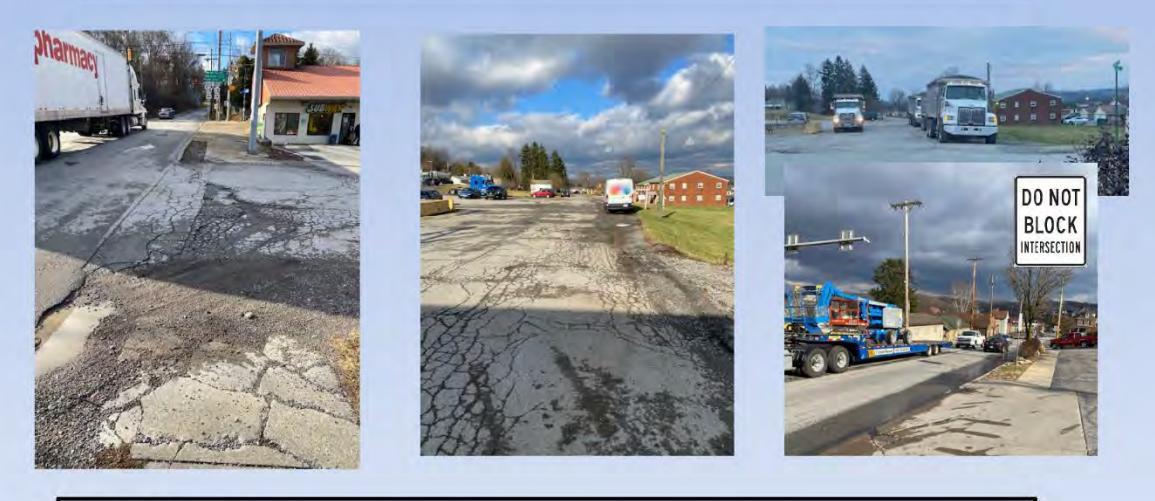
OBSERVATIONS: First Avenue is showing signs of major pavement deterioration. The road is used as an over flow parking lot for AL's Corner Café. Trucks and other motorists were observed parking along the shoulders. There is a missing crosswalk at the intersection. WB motorists block the intersection for left tuning vehicles causing excess delays and aggressive driving.

- Repave First Avenue.
- Restrict parking to one-side of first Avenue to cut down on confusion.
- Add missing crosswalk.
- Add DO NOT BLOCK INTERSECTION sign for WB traffic before the First Avenue intersections.
