Southwestern Pennsylvania Road Safety Audit

**U.S. 119 from Youghiogheny River (Memorial
Bridge) to S.R. 982**

**Bullskin Township, Connellsville Township & City of Connellsville,
Fayette County, PA**

March 2014

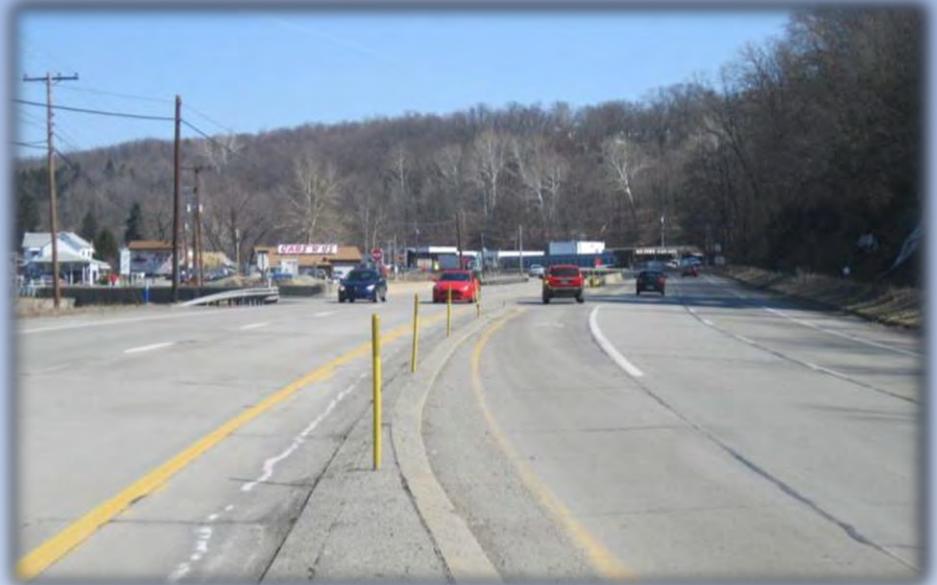
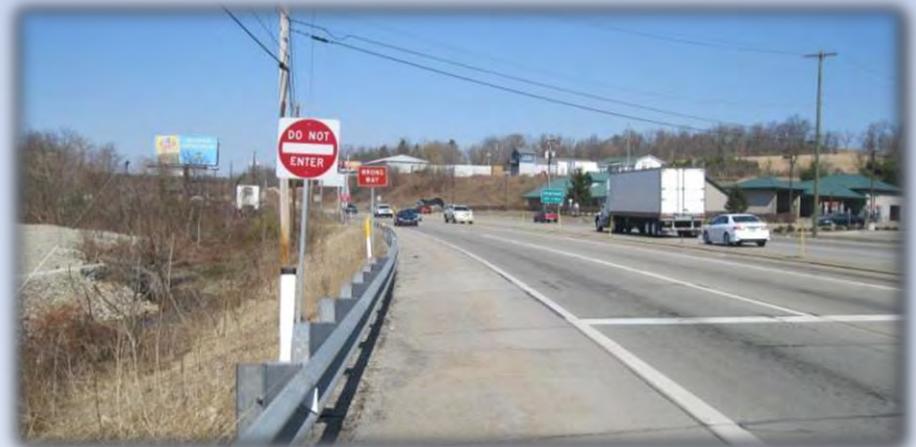
Safety Successes

- Concrete median treatments to reduce/eliminate head-on crashes
- Delineation (quantity and general condition)
- Positive guidance with route signage
- Do Not Enter and Wrong Way signs installed
- Left turn lanes at unsignalized intersections

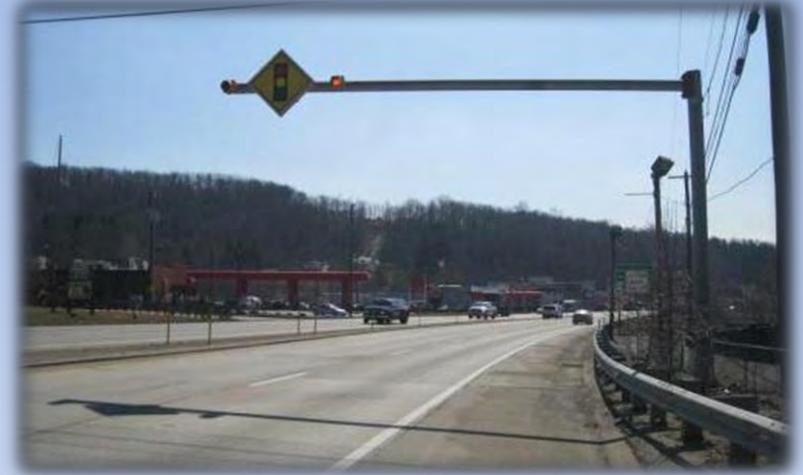
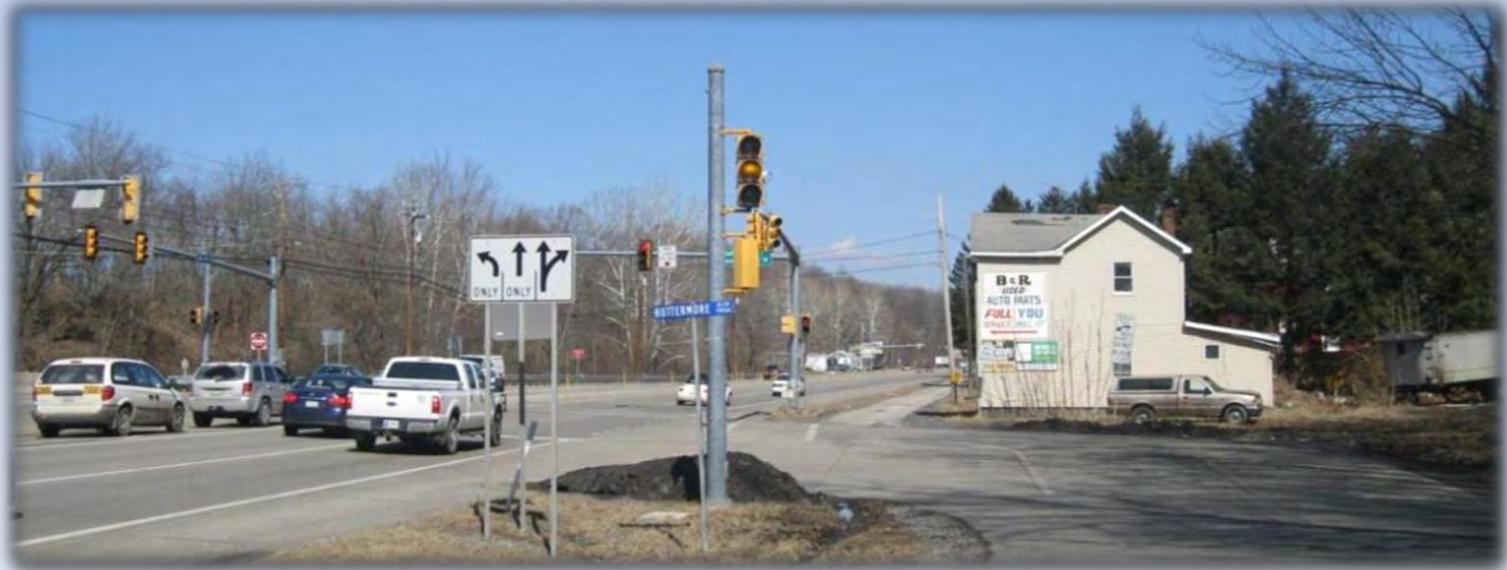
Safety Successes

- Protected left turn phasing at signalized intersections
- Advance warning signs for signalized intersections
- Supplemental signal heads at some locations

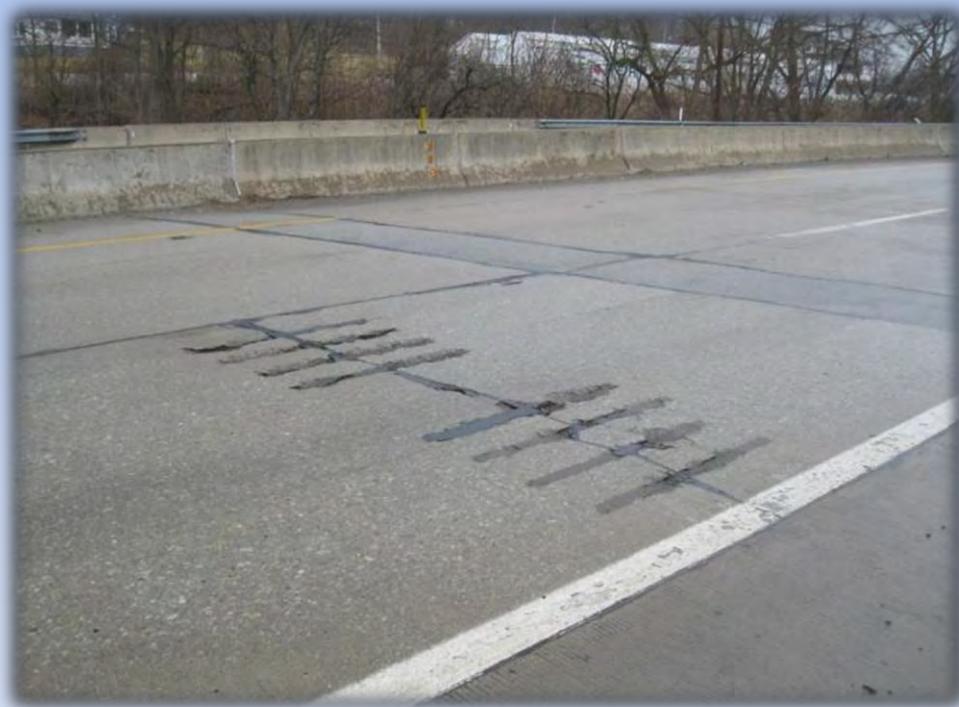
EXPECTED FREQUENCY	EXPECTED SEVERITY	RISK RATING	B
Rare	Low	Moderate-Low	
OBSERVATION: Grooves cut into the concrete pavement at numerous locations (as a pavement preservation treatment) could cause a problem for motorcycles.

- Fill and seal these areas so they are flush with the concrete pavement.

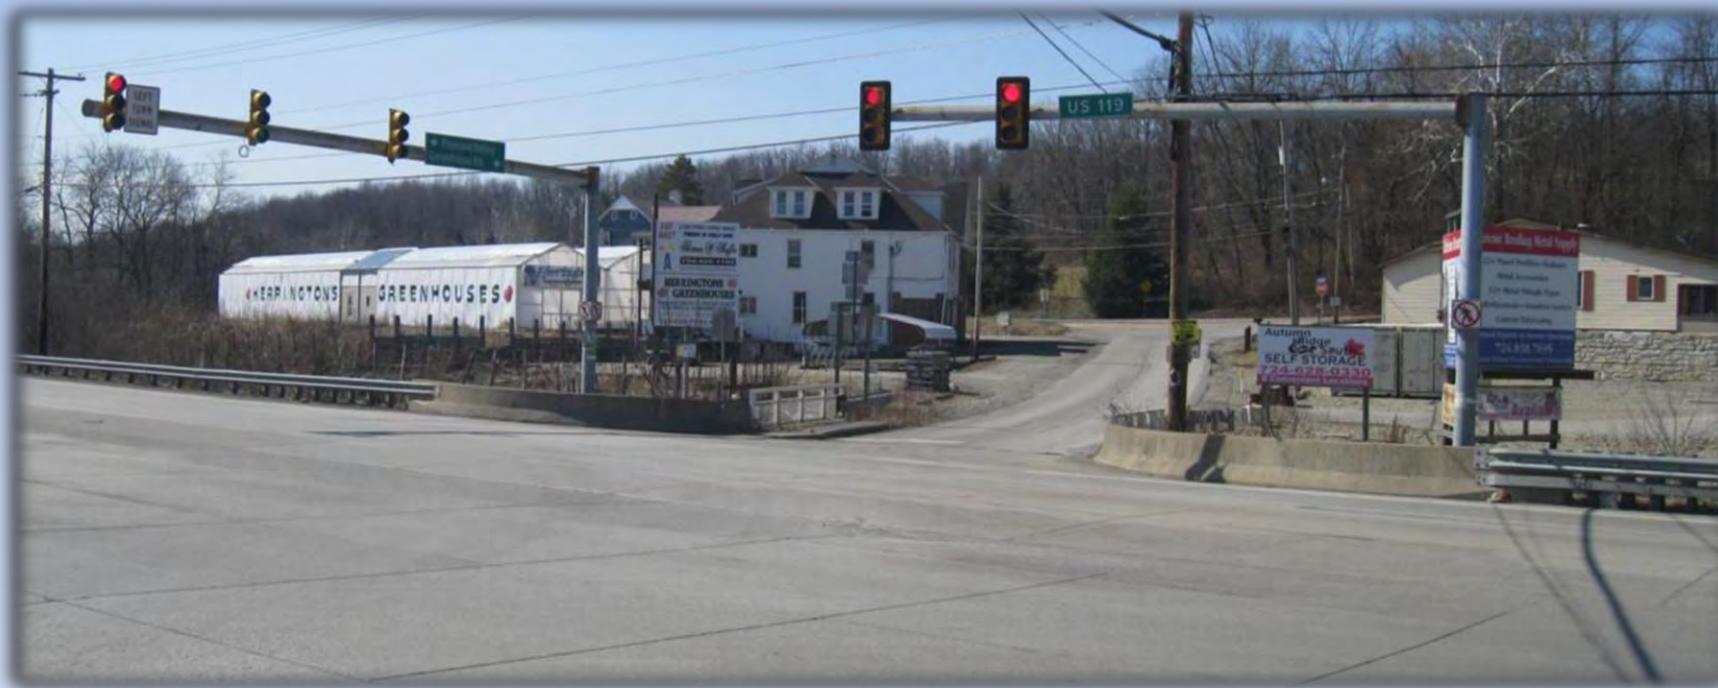
EXPECTED FREQUENCY	EXPECTED SEVERITY	RISK RATING	E
Occasional	High	High	
<p>OBSERVATIONS: Red light running has been a contributing factor in a number of serious crashes along the corridor. Additional clearance interval time and/or dilemma zone detection may be needed, especially at the intersections experiencing high speeds.</p>

<p>SUGGESTIONS:</p> <ul style="list-style-type: none"> • Review clearance interval timings at signalized intersections to ensure that they are adequate and are calculated based on actual 85th percentile speeds. • Consider adding dilemma zone detection on U.S. 119 to minimize the number of high speed vehicles getting a yellow indication.

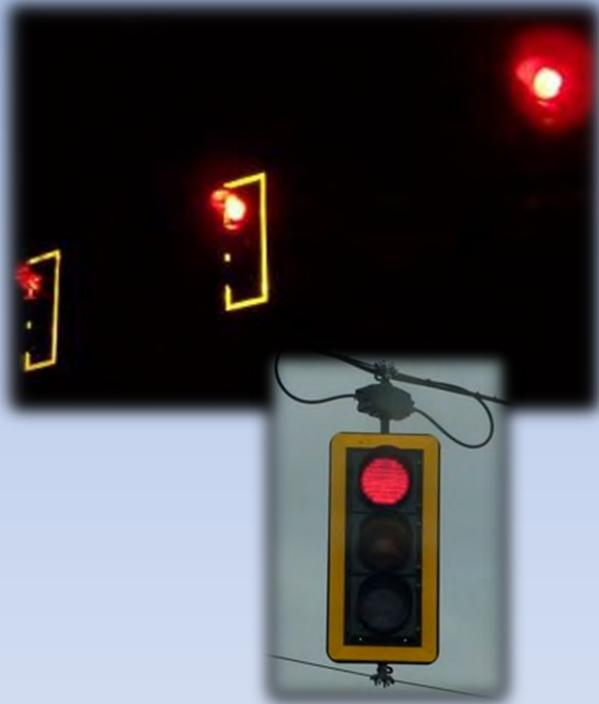
EXPECTED FREQUENCY	EXPECTED SEVERITY	RISK RATING	E
Occasional	High	High	
OBSERVATION: Signal head visibility can be compromised by business signage, utilities, lighting and other items in a driver's field of vision.

- Provide backplates with retroreflective tape on all signal heads.

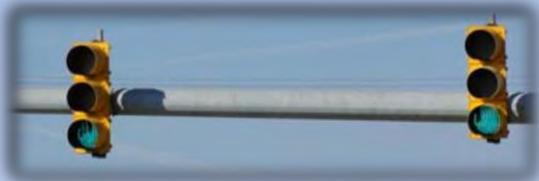
EXPECTED FREQUENCY	EXPECTED SEVERITY	RISK RATING	C
Rare	Medium	Moderate	
OBSERVATION: Maintenance is needed on some traffic signals and advance warning signs.

Green LEDs at S.R. 982 are beginning to go bad

- Perform routine maintenance on signals and signing.

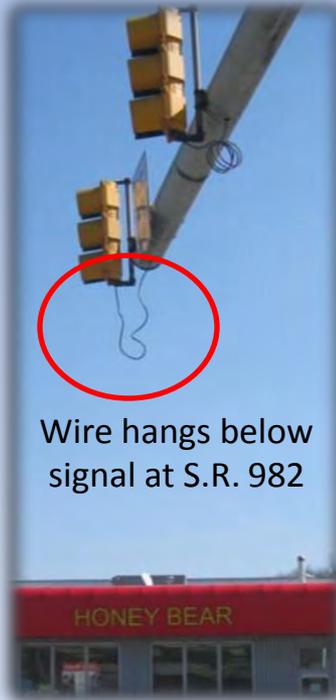
Wire hangs below signal at S.R. 982

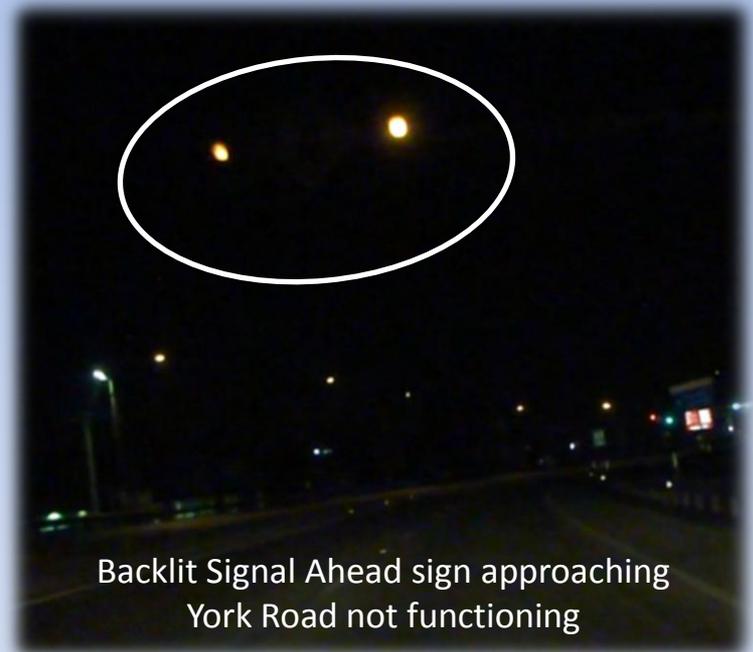
Backlit Signal Ahead sign approaching York Road not functioning

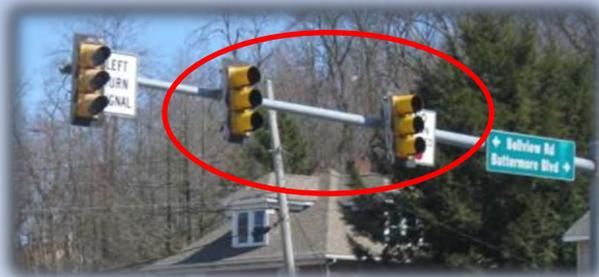
Signal heads at Bellview / Buttermore slightly misaligned

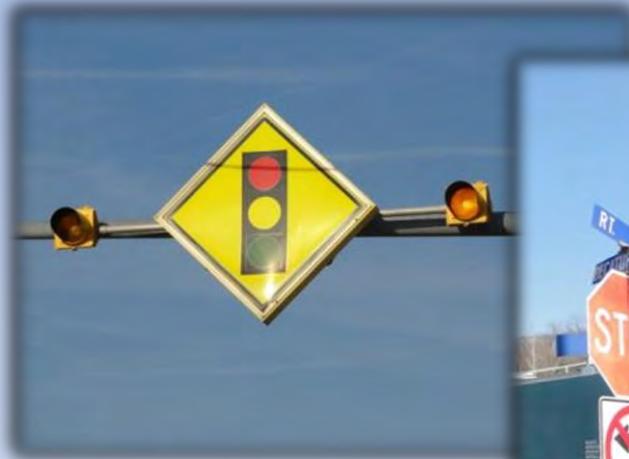
EXPECTED FREQUENCY	EXPECTED SEVERITY	RISK RATING	B
Rare	Low	Moderate-Low	
OBSERVATION: Sign visibility is hampered due to some signs being knocked down and others being faded.

Faded Signs

- Replace faded signs as necessary to maximize visibility.
- Replace sign posts where necessary.

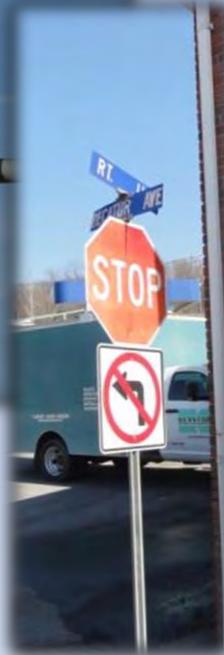
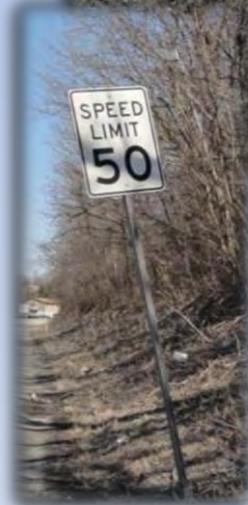
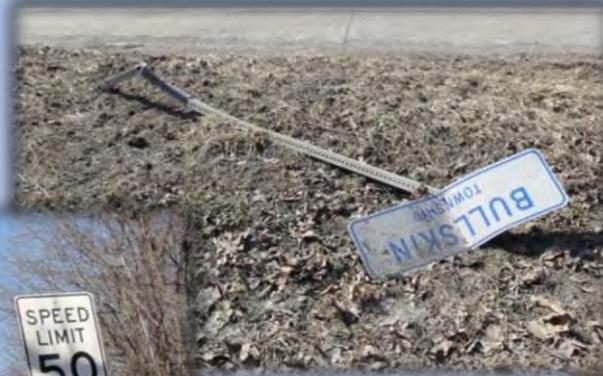
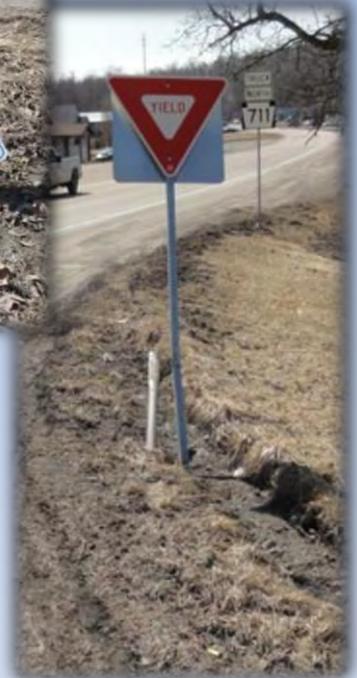
Damaged Signs

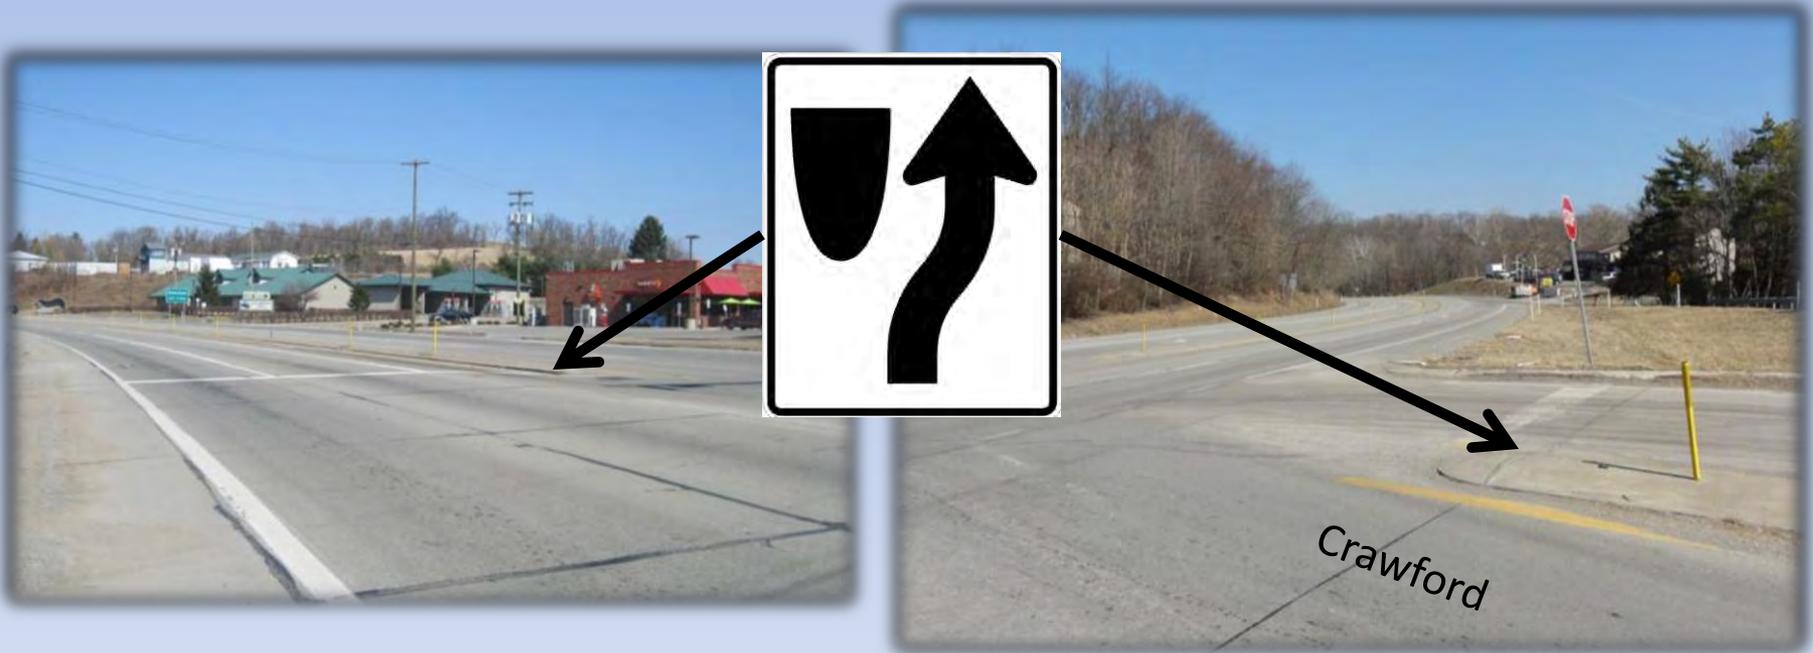
EXPECTED FREQUENCY	EXPECTED SEVERITY	RISK RATING	B
Rare	Low	Moderate-Low	
OBSERVATION: Roadway cross-section (with concrete median dividing northbound and southbound traffic) could result in wrong way driving.

- Provide R4-7 signs on the end of median treatments to supplement existing Do Not Enter and Wrong Way signs.

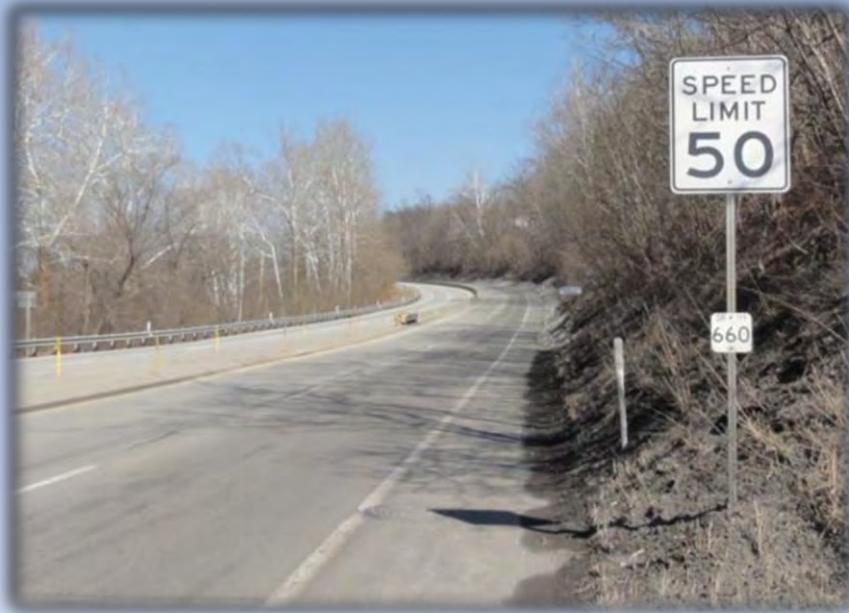
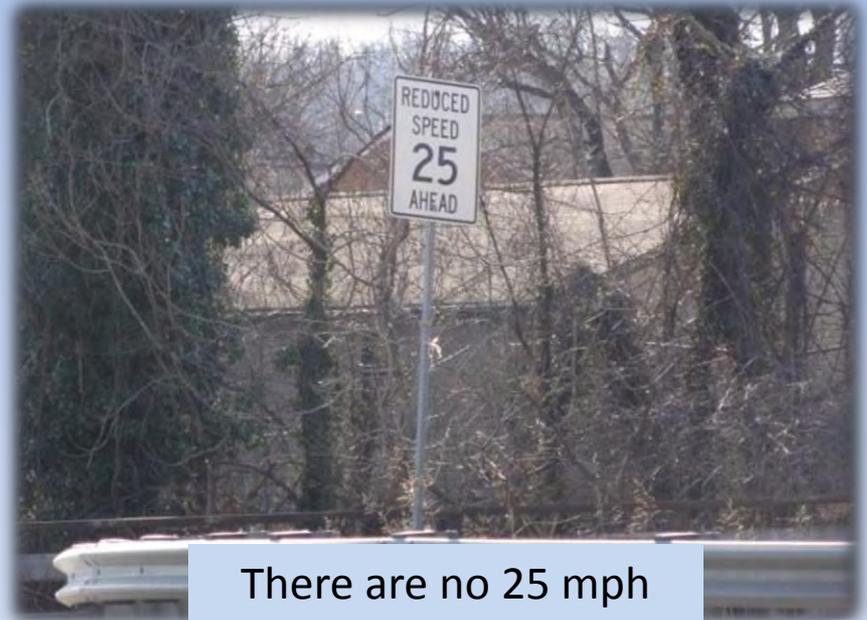
OBSERVATIONS: Existing speed limit signs can be missed by motorists; they are small in size and only located on the right-hand side of the road. There are different NB and SB speed limits through Connellsville. SB speeds approaching the City of Connellsville are particularly high.

There are no 25 mph speed limit signs ahead

- Review existing speed limit signing and make sure it is consistent and appropriate.
- Use larger signs, and try to mount in median as well.

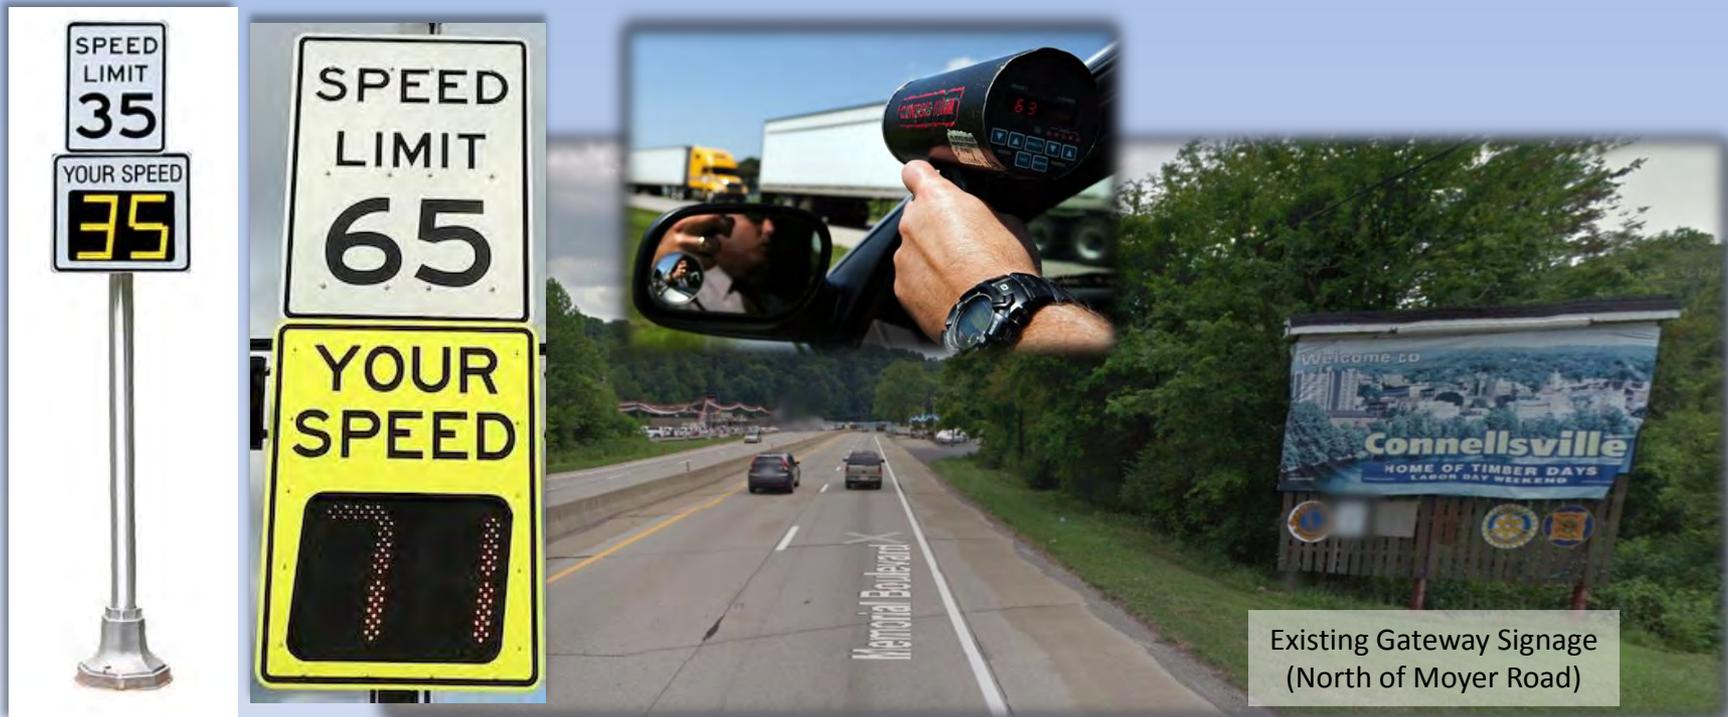
EXPECTED FREQUENCY	EXPECTED SEVERITY	RISK RATING	E
Frequent	Medium	High	
OBSERVATION: Travel speeds frequently exceed posted speed limits.

Existing Gateway Signage
(North of Moyer Road)

- Undertake periodic speed enforcement.
- Install speed feedback signing to supplement regulatory speed limit signs.
- Provide enhanced “gateway” signing and landscaping closer to the City of Connellsville to provide visual cues to motorists.

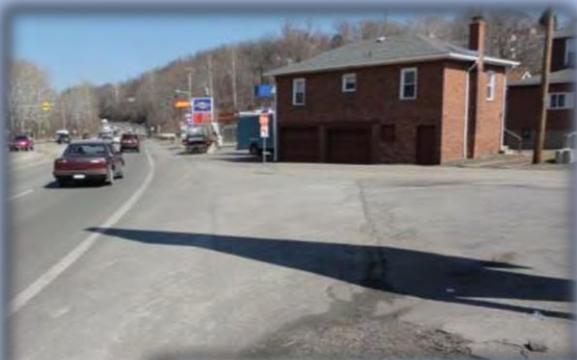
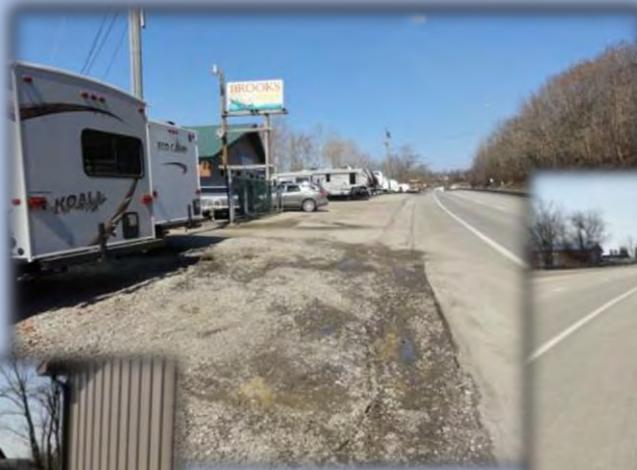
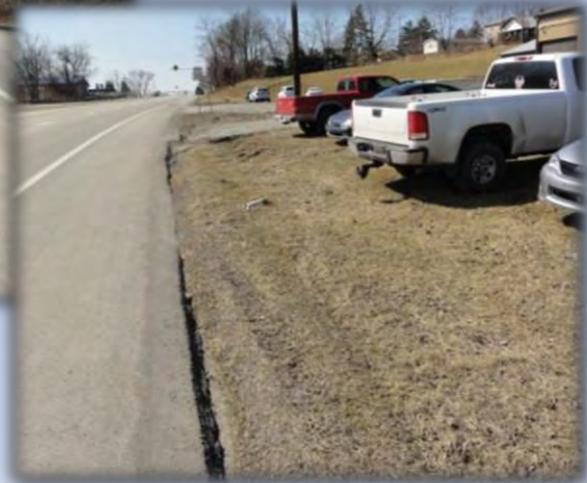
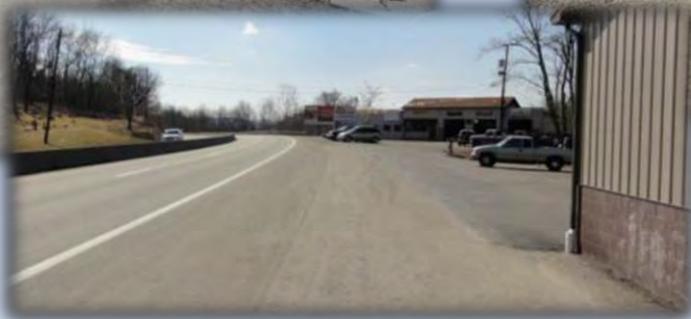
EXPECTED FREQUENCY	EXPECTED SEVERITY	RISK RATING	C
Rare	Medium	Moderate	
OBSERVATION: Many businesses have long, unrestricted access points, resulting in unpredictability of vehicles entering and exiting U.S.119.

- Work with local businesses to consolidate the number and width of access points.
- Limit access points using the HOP process and local ordinances as part of future development/redevelopment.

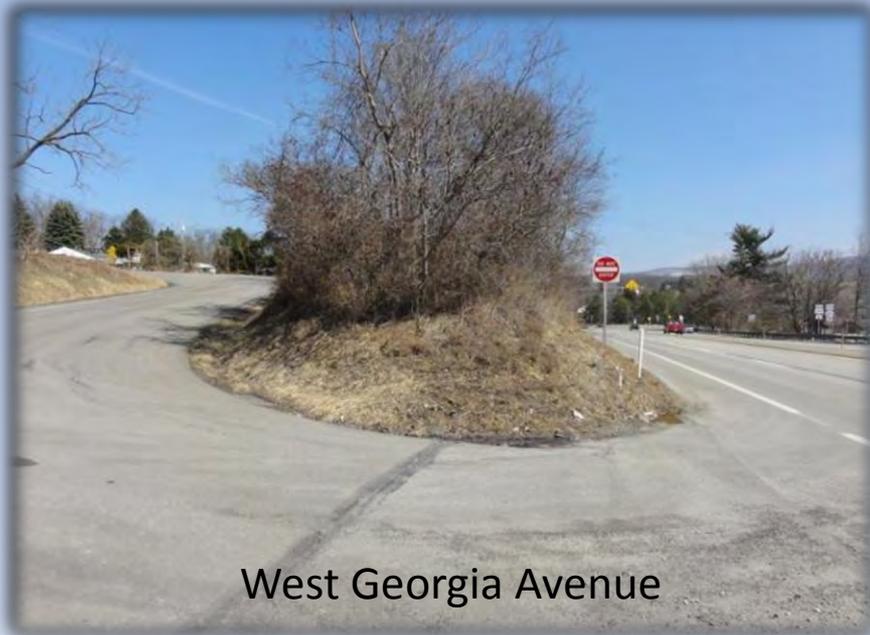
West Georgia Avenue

EXPECTED FREQUENCY	EXPECTED SEVERITY	RISK RATING	C
Rare	Medium	Moderate	
OBSERVATION: Some unsignalized access points on U.S. 119 have poor sight distances due to approach geometry or embankments.

- Restrict or eliminate access points where other access alternatives exist, particularly when it is possible to enter U.S. 119 at a signal.
- Remove sight distance obstructions where appropriate.

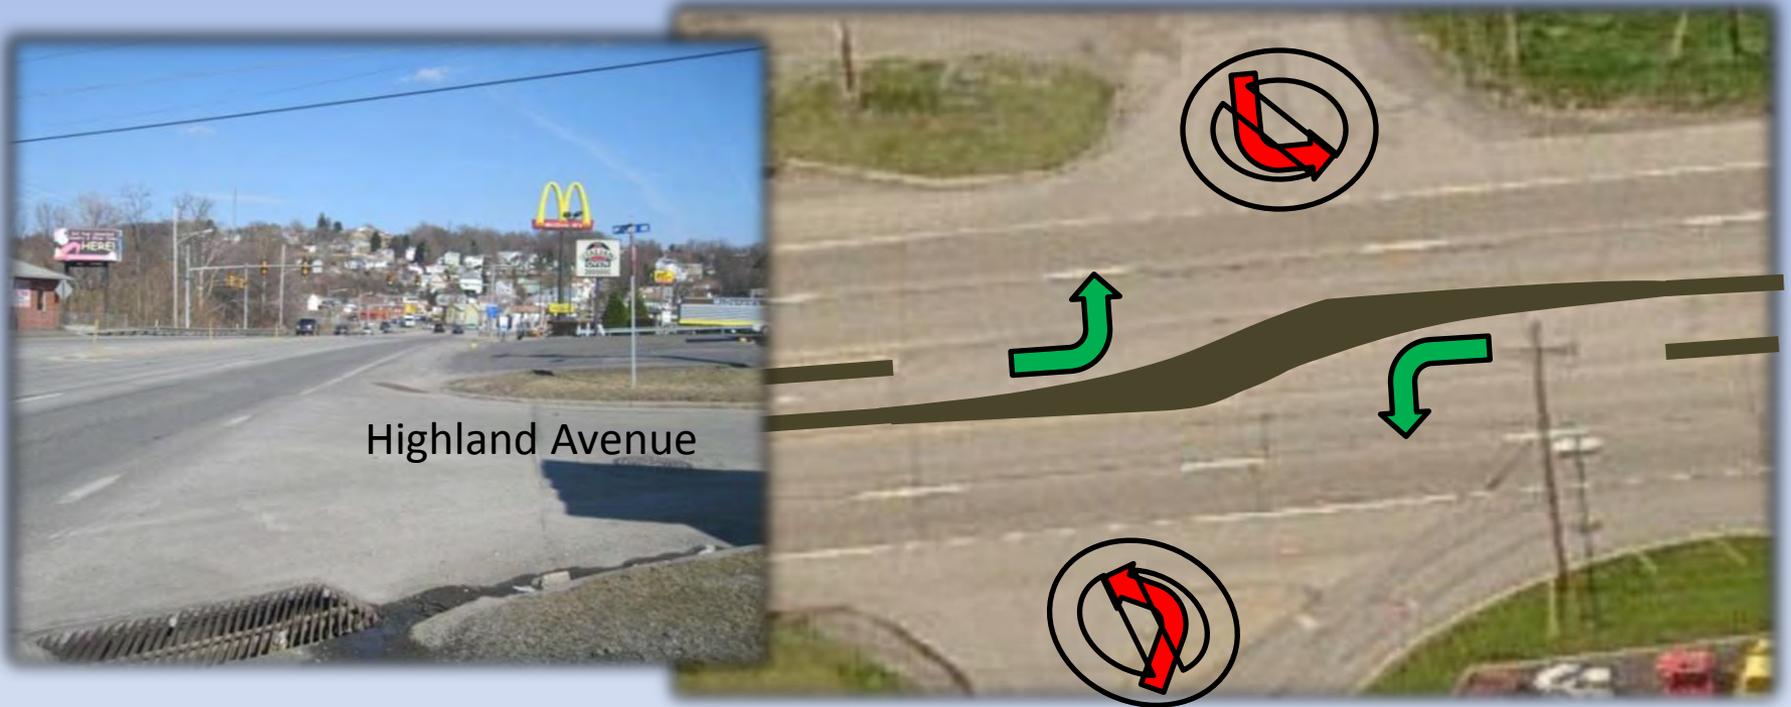
EXPECTED FREQUENCY	EXPECTED SEVERITY	RISK RATING	D
Occasional	Medium	Moderate-High	
OBSERVATION: Numerous unsignalized access points allow left turns onto U.S. 119, which creates many turning movement conflicts.

- Prohibit left turns onto U.S. 119, either through signage or median design, at all unsignalized locations.

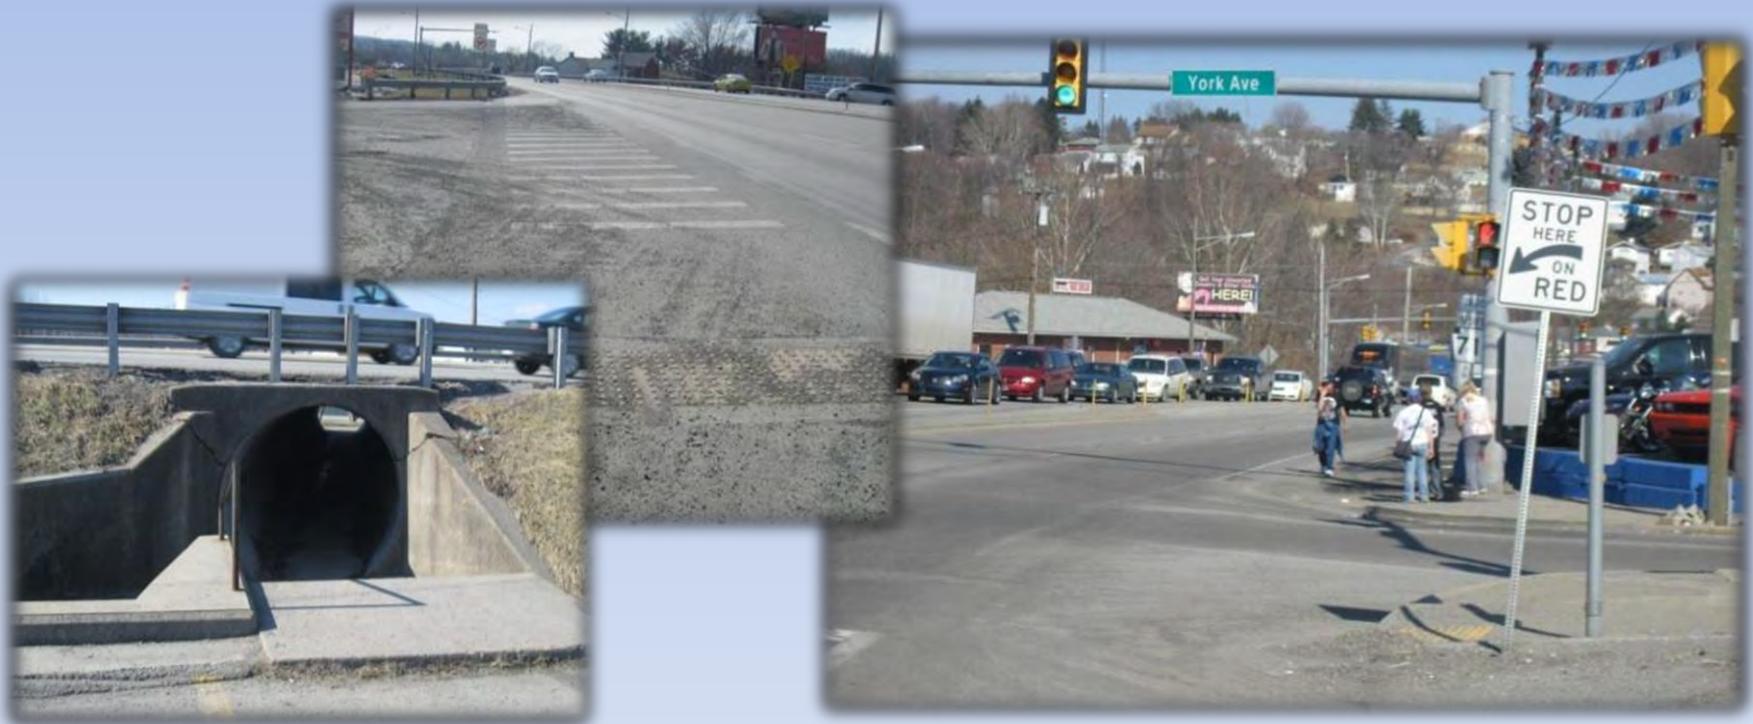
OBSERVATION: Pedestrian infrastructure is sporadic, inconsistent, and disconnected. Side streets in the City typically have sidewalks, but there are no sidewalks along U.S. 119.

- Take a “Complete Streets” approach to future rehabilitation/reconstruction in this corridor, including sidewalks along U.S. 119.

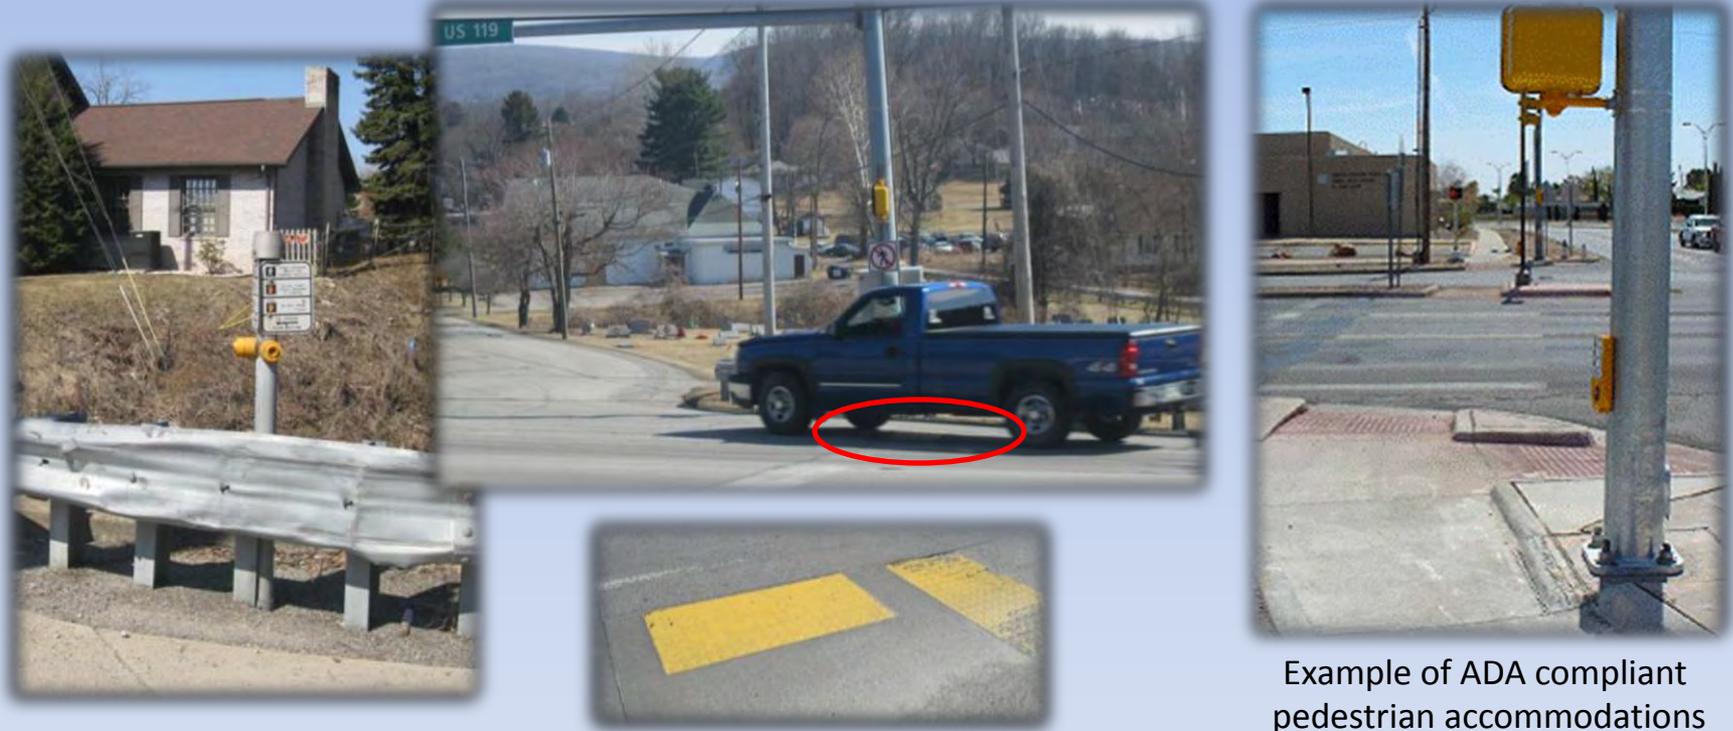
EXPECTED FREQUENCY	EXPECTED SEVERITY	RISK RATING	B
Rare	Low	Moderate-Low	
OBSERVATION: Many pedestrian facilities do not meet current ADA standards.

Example of ADA compliant pedestrian accommodations

- Modify sidewalks, crosswalks, curb lines, curb ramps, and other pedestrian infrastructure to meet ADA requirements as other improvements are implemented.

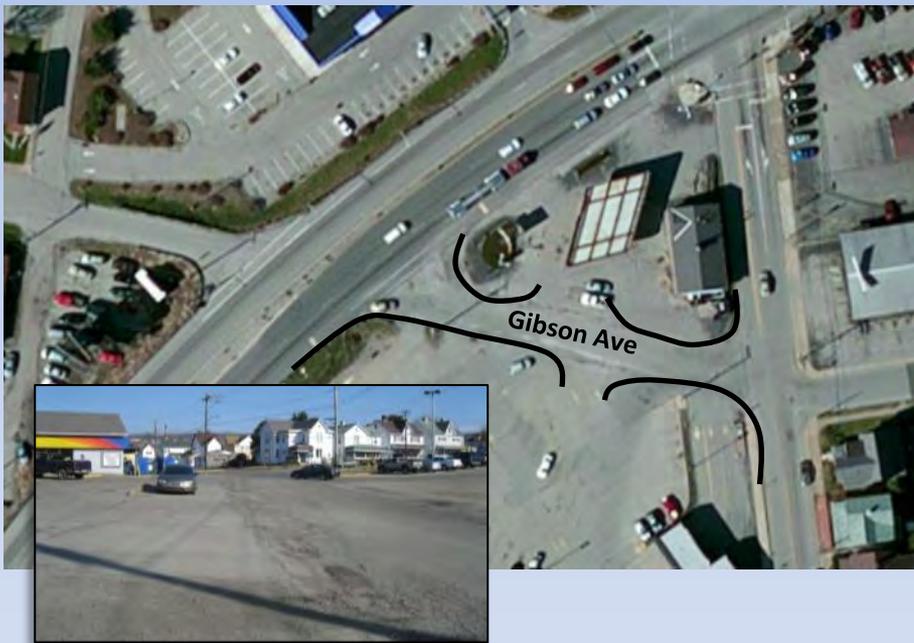
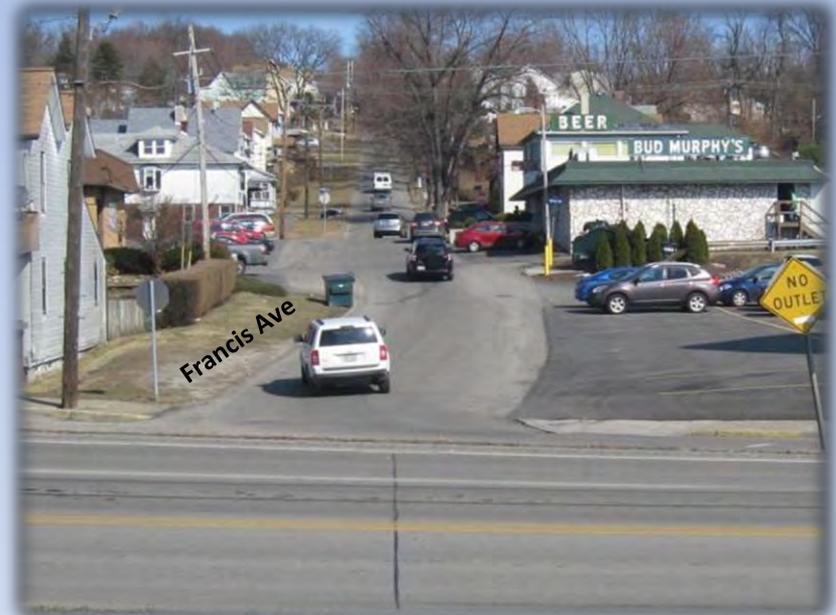
EXPECTED FREQUENCY	EXPECTED SEVERITY	RISK RATING	B
Rare	Low	Moderate-Low	
OBSERVATION: Developments are primarily designed for motor vehicle trips and do not encourage other modes. Side streets and parking areas are not clearly defined.

Smart Transportation Concepts

- Require transportation impact studies as part of future development.
- Ensure that Subdivision and Land Development Ordinances encourage access management and parcel interconnection.
- Provide curb and sidewalks to differentiate streets from parking areas.

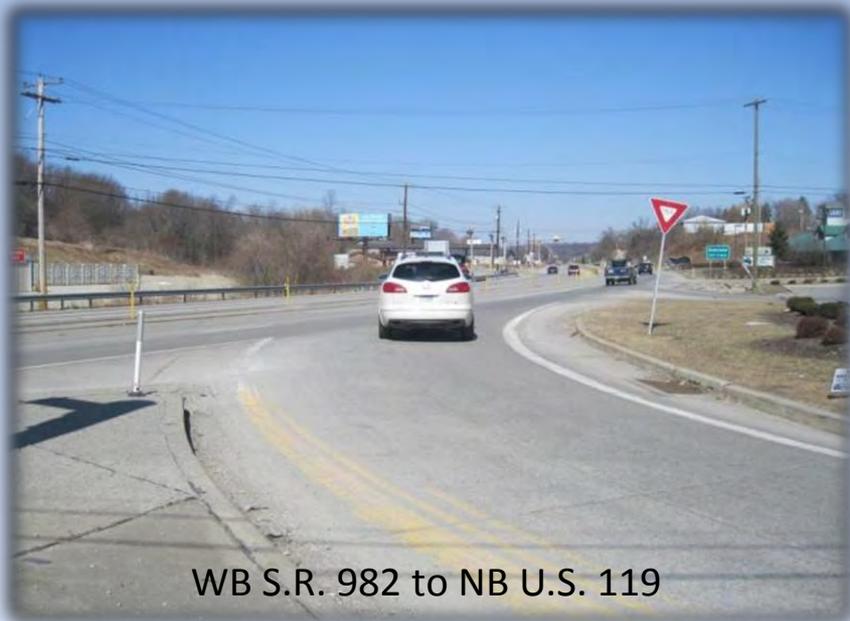
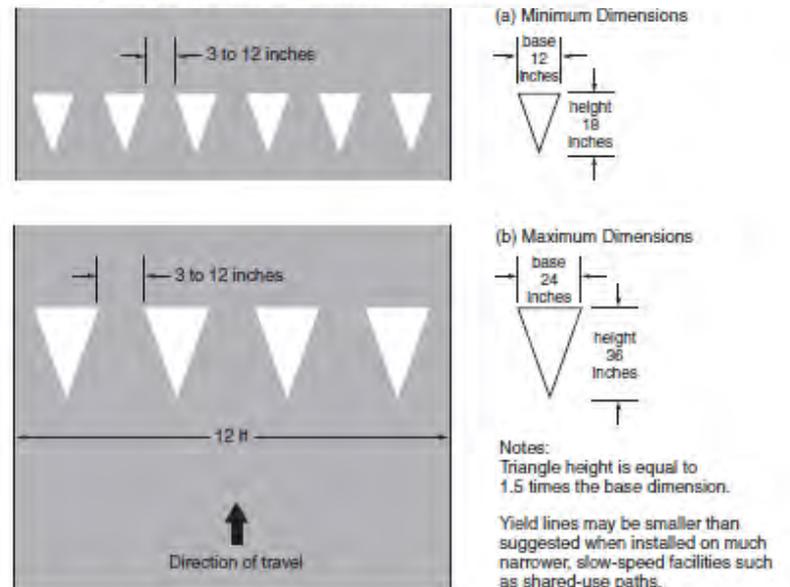
OBSERVATIONS: Yield and Stop signs in channelized right turn lanes could be missed by drivers due to approach angles. It is difficult for drivers, particularly older drivers, to look over their left shoulders at these locations (S.R. 982 and Crawford in particular).

Figure 3B-16. Recommended Yield Line Layouts (from MUTCD)

- Short term: Provide supplemental pavement markings at these locations.
- Long term: Eliminate channelized locations and replace with dedicated right-turn lane with right-turn overlap phase. (See example on following page)

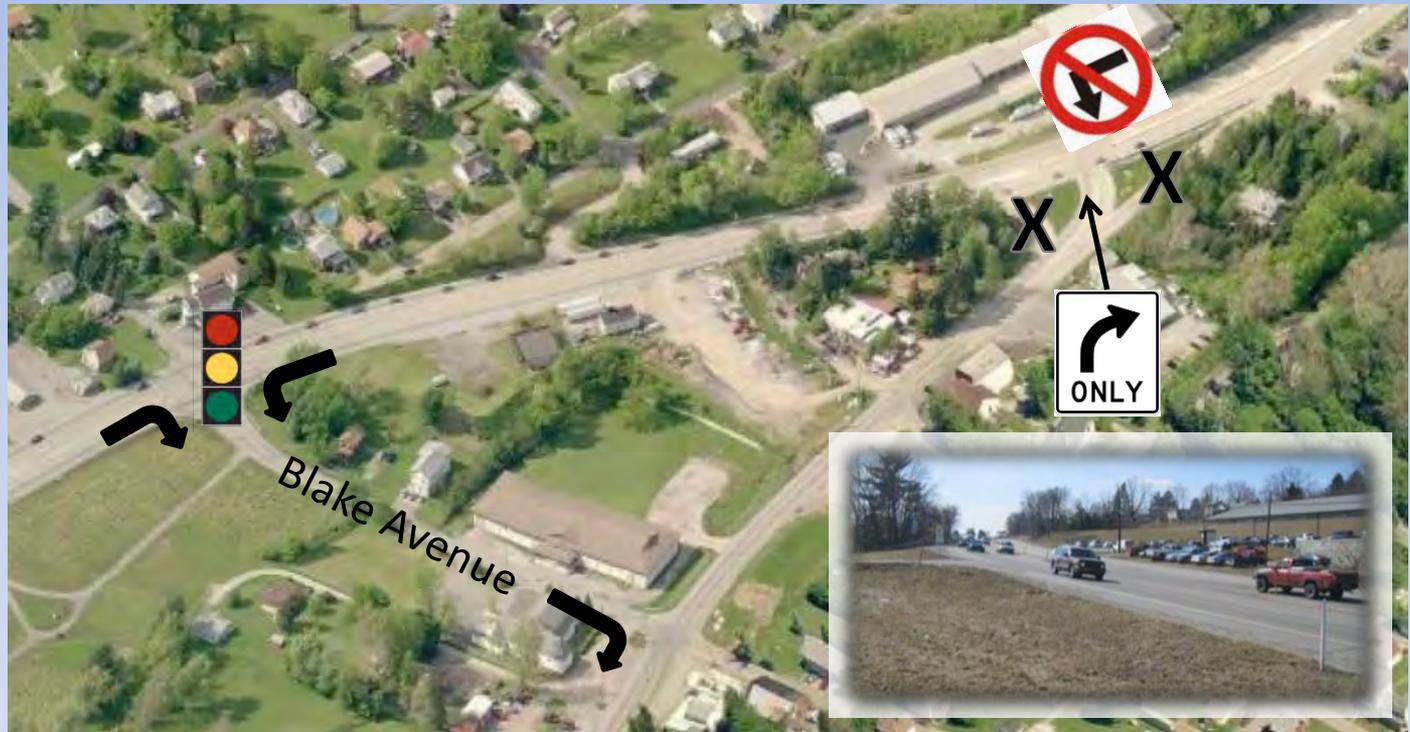
EXPECTED FREQUENCY	EXPECTED SEVERITY	RISK RATING	E
Occasional	High	High	
OBSERVATION: Complex geometry (including superelevation) and sun glare can make judging gaps in traffic and executing turning movements difficult at Crawford Avenue.

- Limit turning movements at Crawford Avenue to NB right turn only and sign other movements to use Blake Avenue.

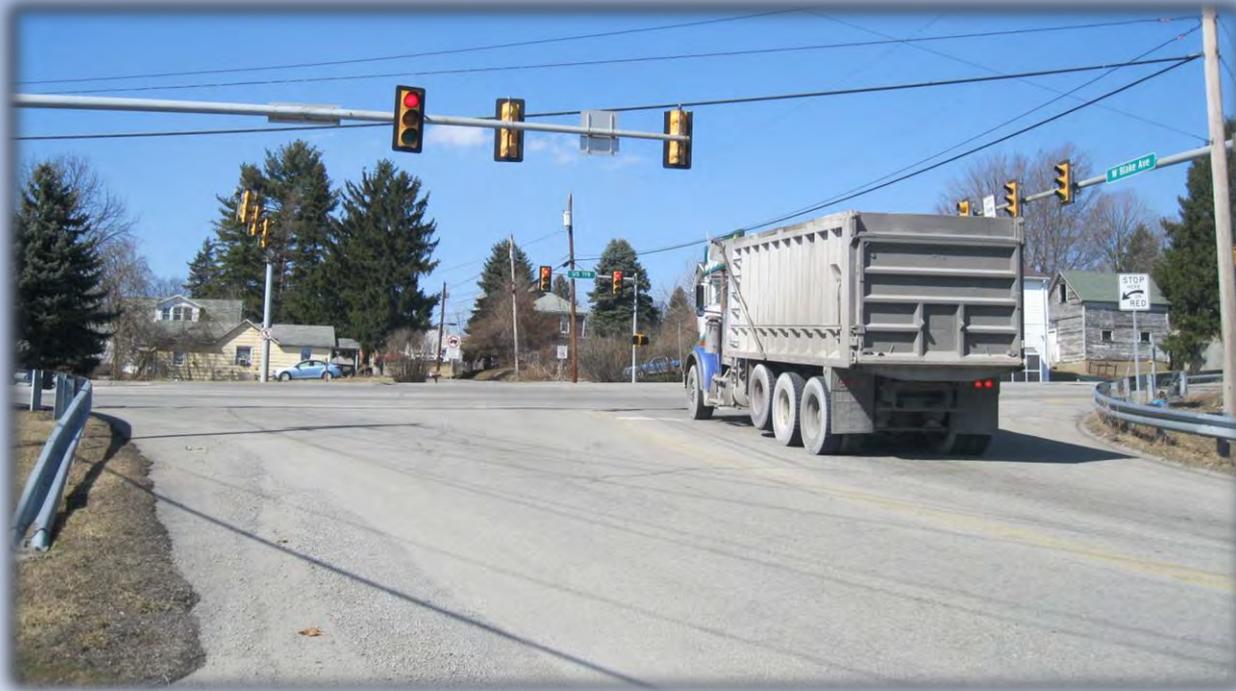
OBSERVATION: WB vehicles on Blake Avenue (particularly trucks and buses) have a difficult time clearing the intersection during the allotted signal phase due to approach grades and the relatively short amount of green time for this approach.

- Review signal timing and consider extending the green phase for this approach.

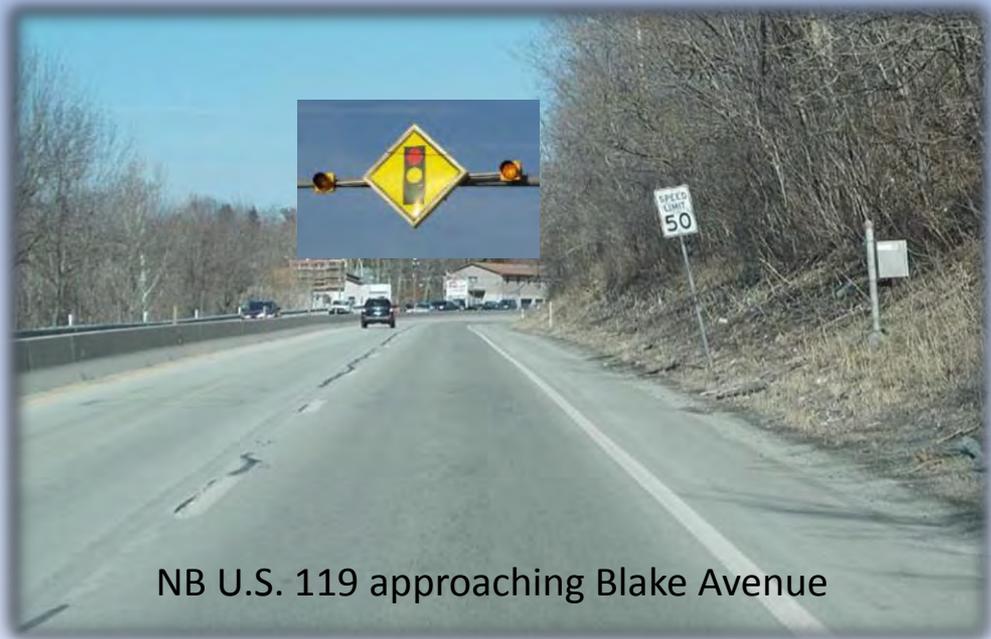
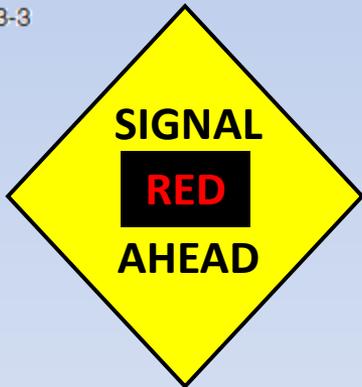
EXPECTED FREQUENCY	EXPECTED SEVERITY	RISK RATING	D
Occasional	Medium	Moderate-High	
<p>OBSERVATIONS: Overhead advance signal ahead devices are present along the corridor except on U.S. 119 approaching Blake Avenue. Existing signal ahead devices may not be placed far enough in advance to give effective notification due to speeds.</p>

- Install advance signal ahead devices on NB and SB U.S. 119 approaching Blake Avenue.
- Consider relocating or supplementing existing signal ahead warning devices and locating additional devices based on actual speeds rather than posted speeds.
