Southwestern Pennsylvania Road Safety Audit

**U.S. 119 from Youghiogheny River (Memorial
Bridge) to S.R. 982**

**Bullskin Township, Connellsville Township & City of Connellsville,
Fayette County, PA**

March 2014

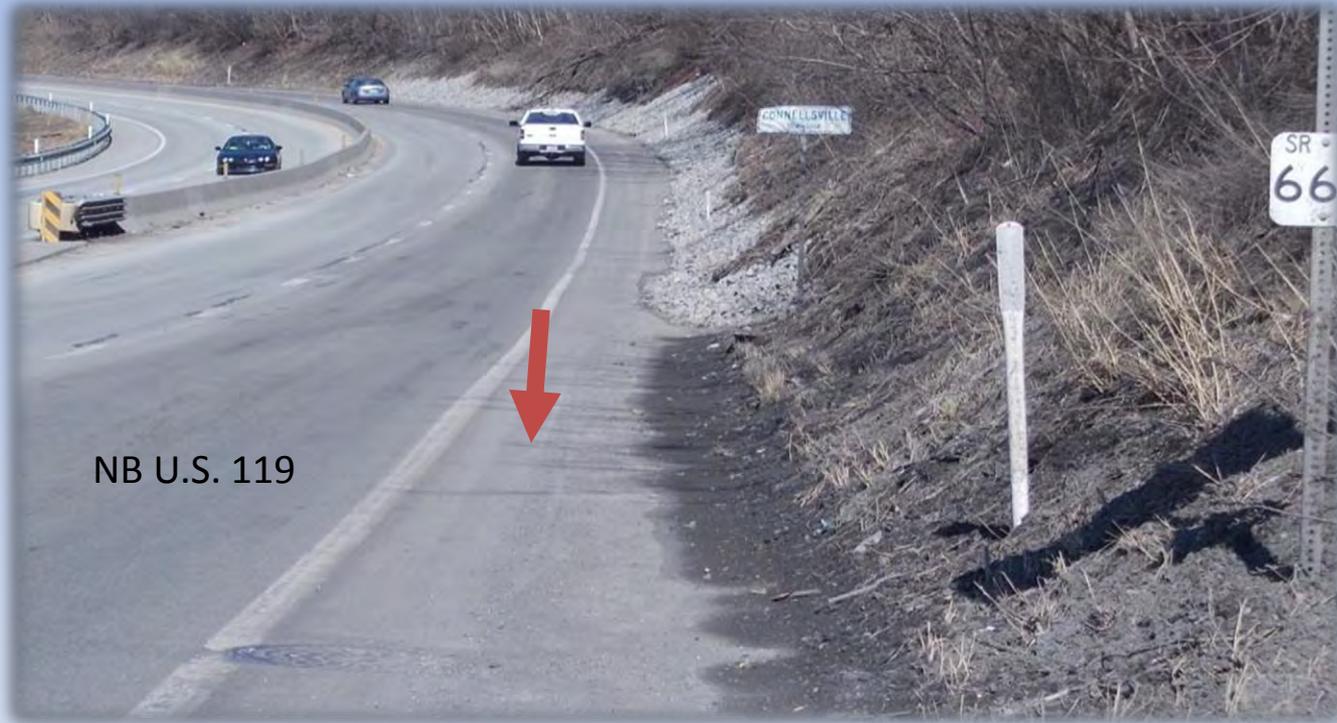
NB U.S. 119

OBSERVATION: Shoulder rumble strips are installed in portions of the corridor but are not present between North Pittsburgh Street Extension and Buttermore Avenue.

- Install edge line or shoulder rumble strips along U.S. 119 between North Pittsburgh Street Extension and Buttermore Avenue.

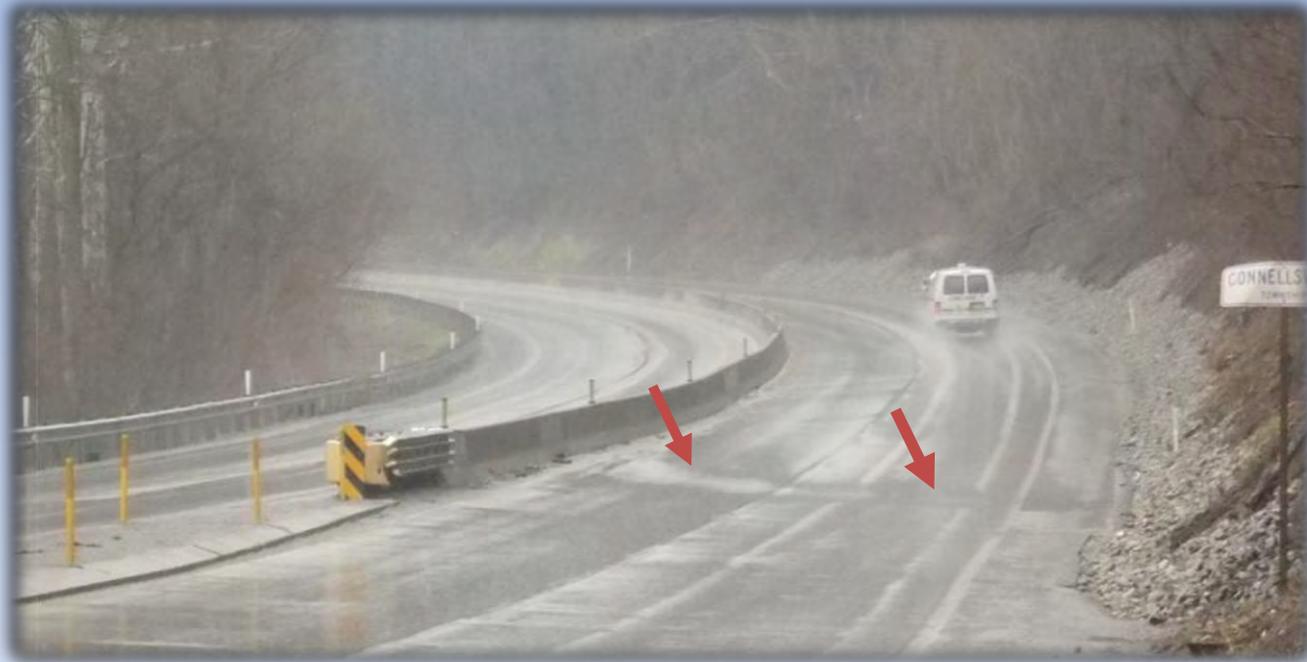
EXPECTED FREQUENCY	EXPECTED SEVERITY	RISK RATING	C
Rare	Medium	Moderate	
OBSERVATION: Inadequate drainage creates ponding along S.R. 0119 between Pittsburgh Street and Blake Avenue.

SUGGESTIONS: <ul style="list-style-type: none">• Perform maintenance to clear debris from inlets.• Make drainage improvements to prevent water from ponding on travel lanes.

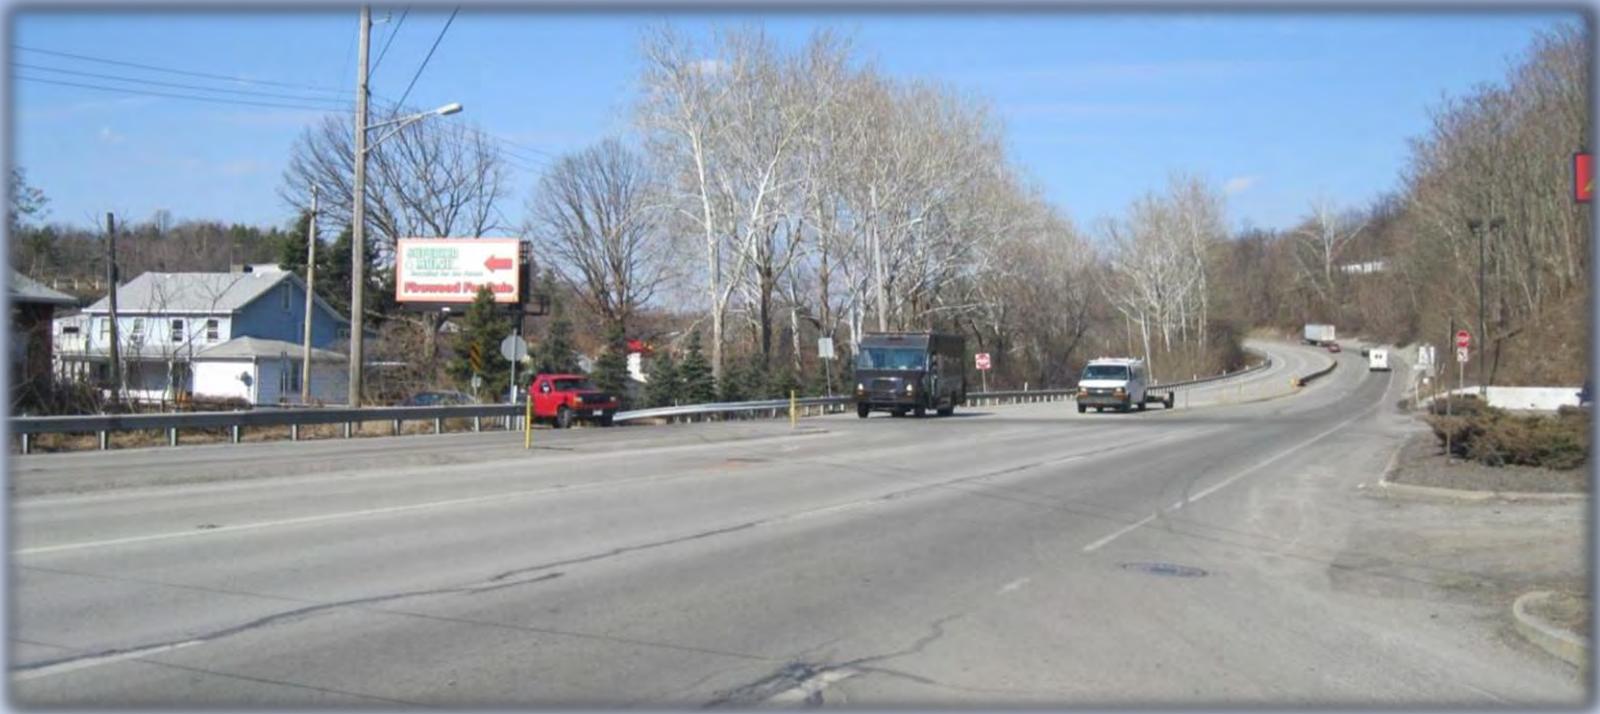
EXPECTED FREQUENCY	EXPECTED SEVERITY	RISK RATING	D
Rare	High	Moderate-High	
OBSERVATION: Opposing left turning vehicles at North Pittsburgh Street Extension and Advanced Auto can block sight distance and limit visibility of oncoming traffic.

- Utilize the northern driveway at Advance Auto for ingress in order to move left turning traffic further north.

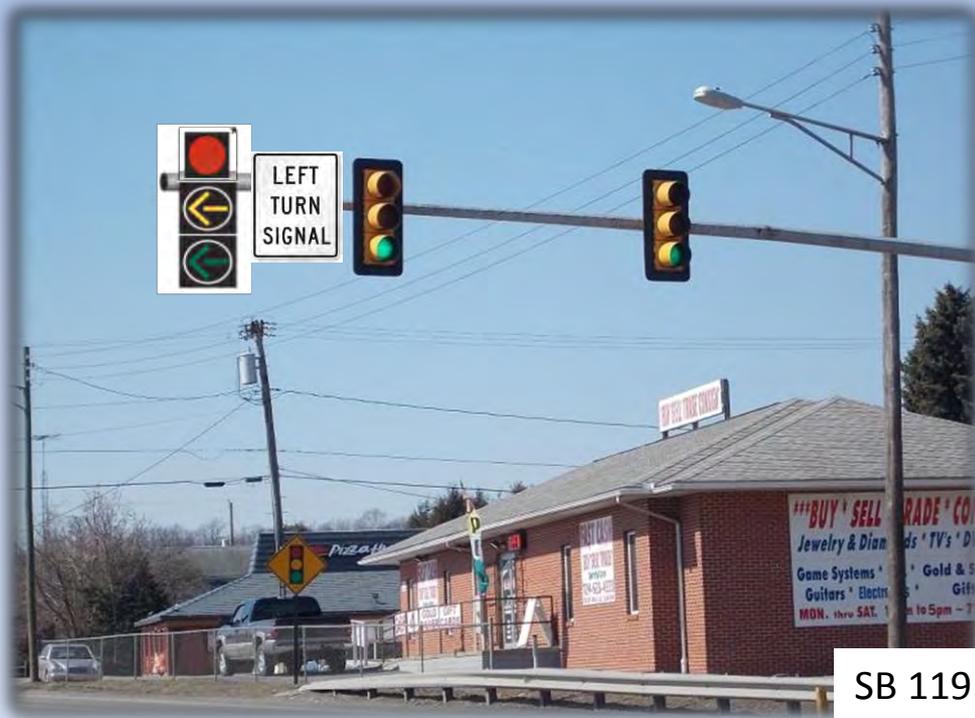
OBSERVATION: Protected left turn phasing is utilized throughout the U.S. 119 corridor, with the exception of the McDonald's intersection.

- Add protected-only left turn phasing, a three-section signal head, and appropriate signage at this signal.

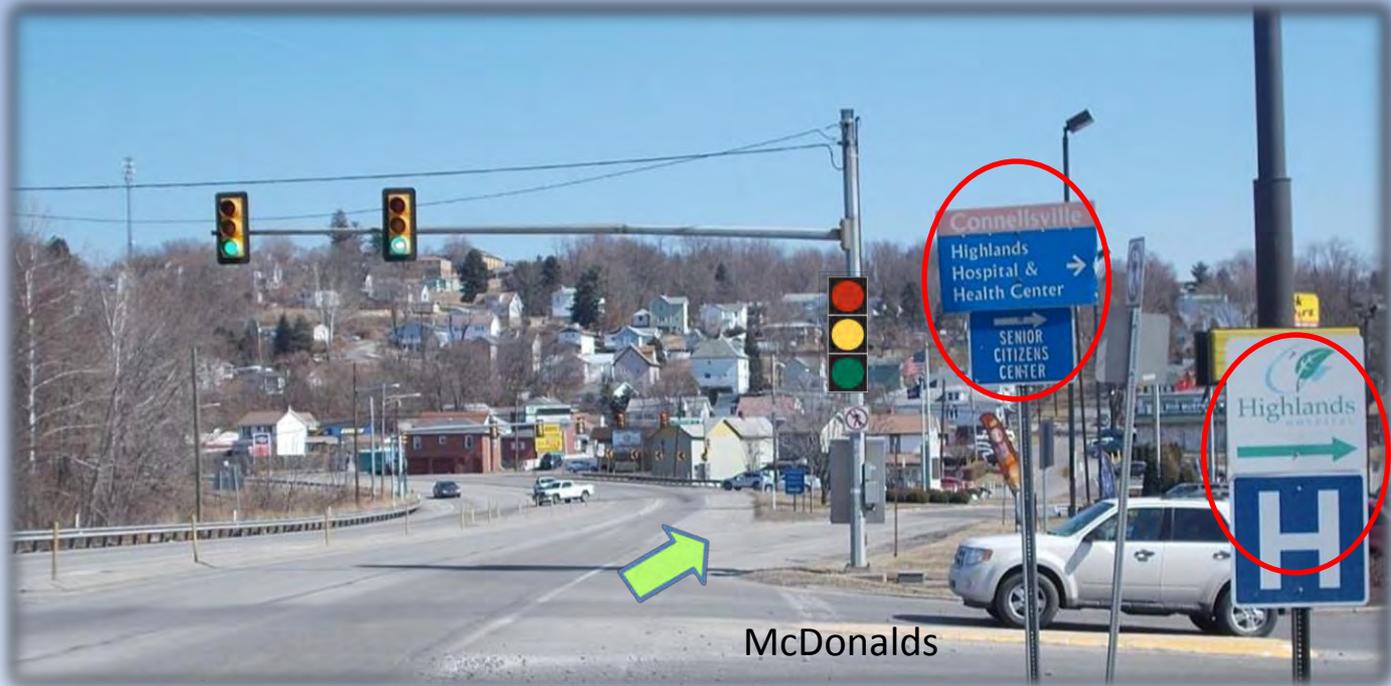
OBSERVATION: The traffic signal at McDonalds could be overlooked by NB motorists due to anticipation of the right turn ramp, wide shoulder, and signage.

- SUGGESTIONS:
- Consider adding a supplemental signal head on the mast arm at the McDonalds driveway.
 - Consider relocating the Highlands Hospital and other wayfinding signage.

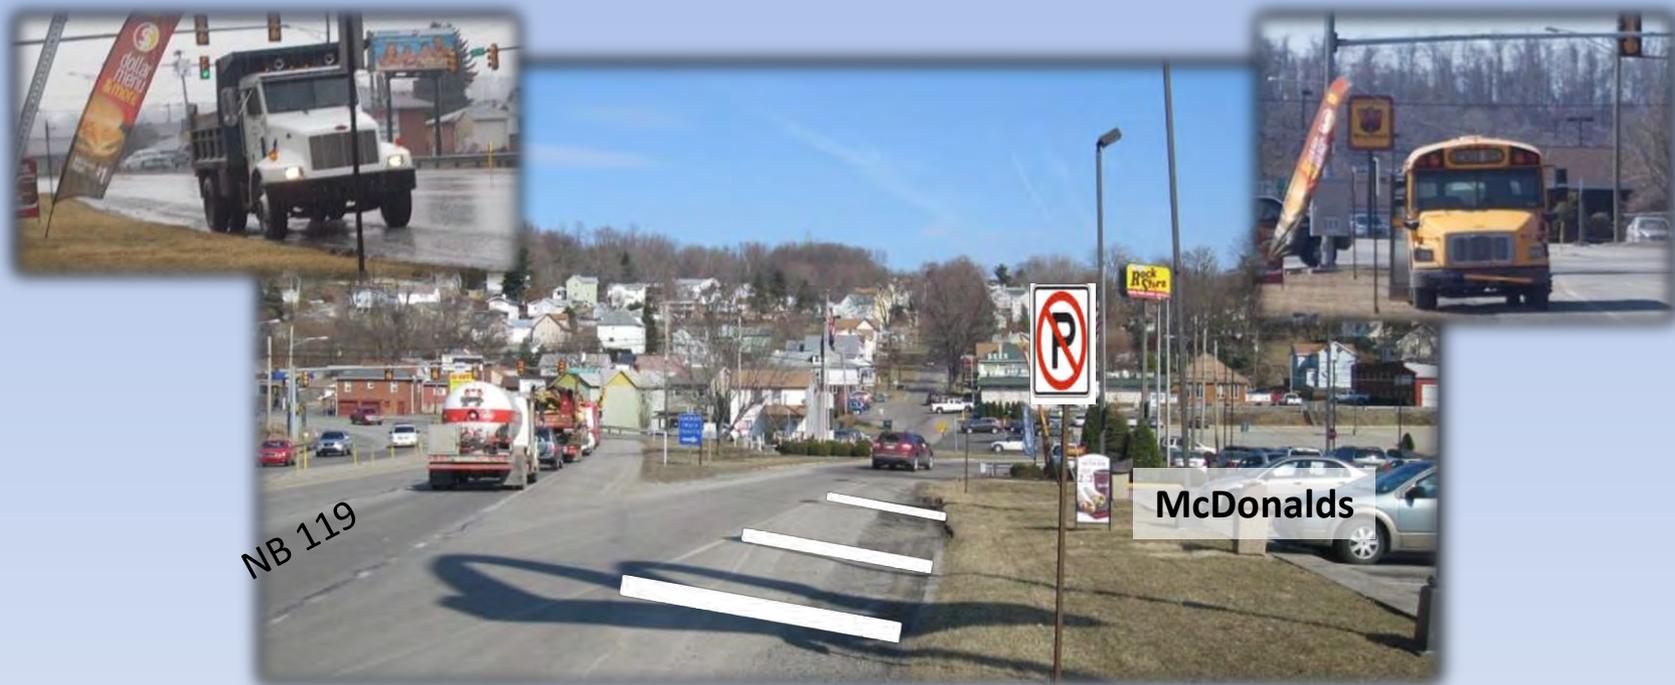
OBSERVATION: Large vehicles were observed parking along the right-turn ramp to access McDonalds in violation of the no parking signs.

- SUGGESTIONS:
- Install new “no parking” signs
 - Use pavement markings to hatch shoulder.
 - Increase enforcement.

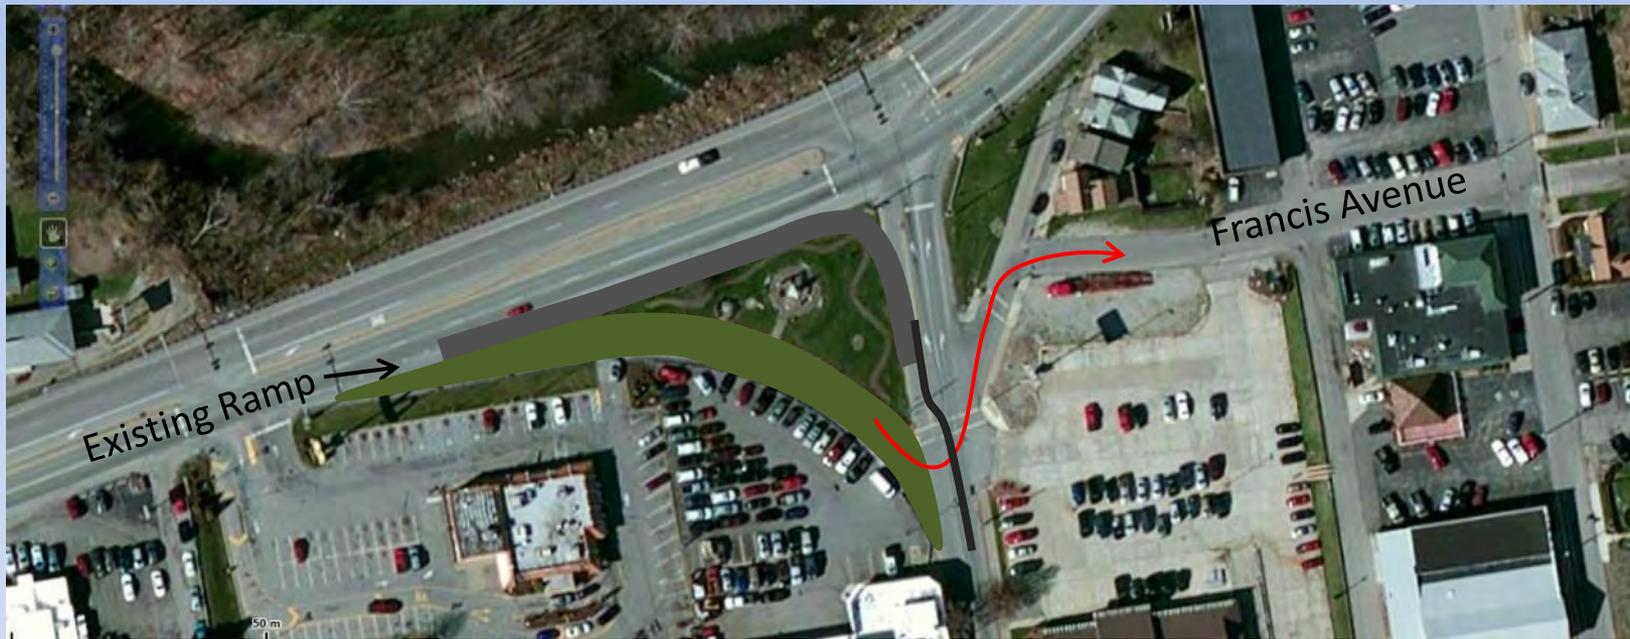
EXPECTED FREQUENCY	EXPECTED SEVERITY	RISK RATING	C
Occasional	Low	Moderate	
<p>OBSERVATION: Channelized right turn ramp from NB U.S. 119 to North Pittsburgh Street encourages high speed movements, creates conflicts at the McDonalds signal, and results in unpredictable turning movements between the ramp and Francis Avenue.</p>

- Eliminate the high speed ramp by creating a right turn lane (with overlap phase) that runs through the signalized intersection.
- Install a mountable concrete median on North Pittsburgh Street to eliminate left turns onto Francis Avenue.

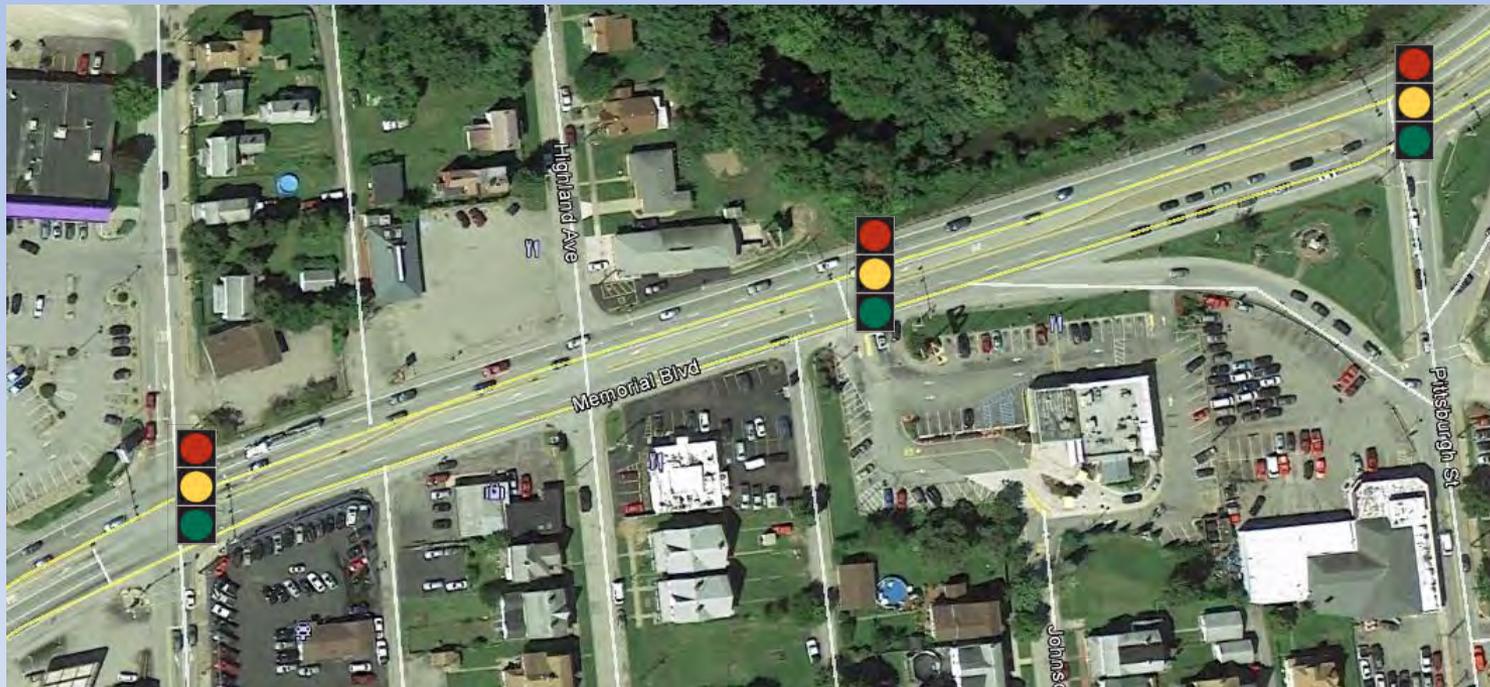
OBSERVATION: The close proximity of the signals at York, McDonalds and Pittsburgh Street causes congestion along the U.S. 119 corridor.

- Evaluate the timing and coordination of York Avenue, McDonalds and Pittsburgh Street signals to ensure that mainline U.S. 119 is receiving maximum progression.

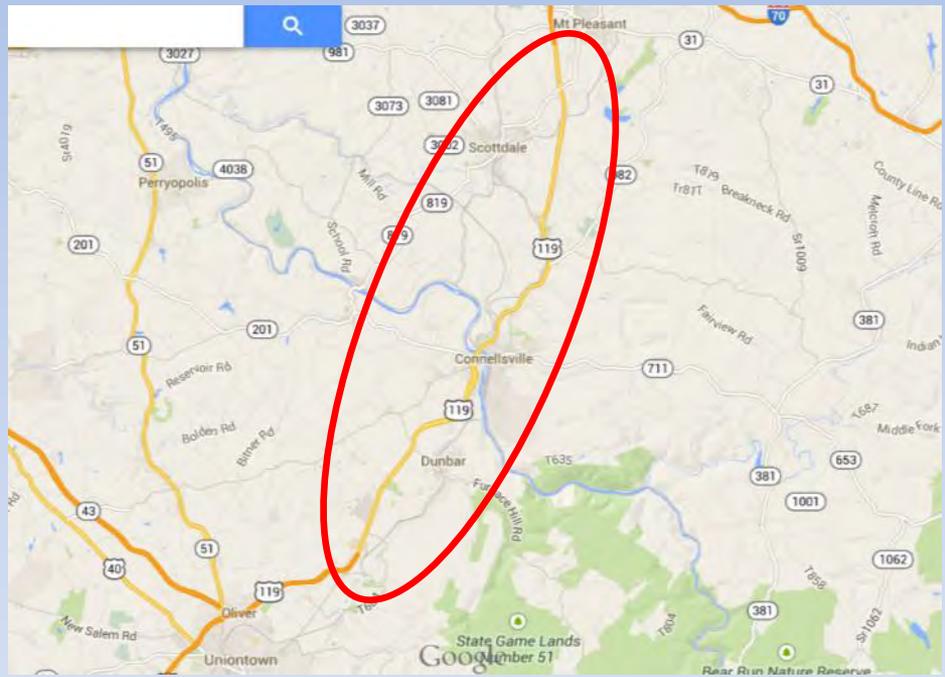
OBSERVATION: U.S. 119 is a high speed limited access freeway in some areas of Fayette and Westmoreland Counties, has at-grade signalized intersections in some areas, and is a highly developed urban corridor through Connellsville. The cross-section of the road does not differ significantly with the varying land use contexts so speeds tend to remain high throughout.

- Consider potential long-term changes to this corridor as part of the Laurel Ridge travelshed of the Regional Operations Plan in order to improve operations and safety.
